# ARCHITECH

HOME INSPECTION SYSTEMS, LLC

123 Anykine Dr, Honolulu , Hawaii 96888

**Inspection Date:**  
11/12/2008  
**Prepared For:**  
Ver E. Important  
**Report Number:**  
20081014-BN-1  
**Inspector:**  
Bryan Naff

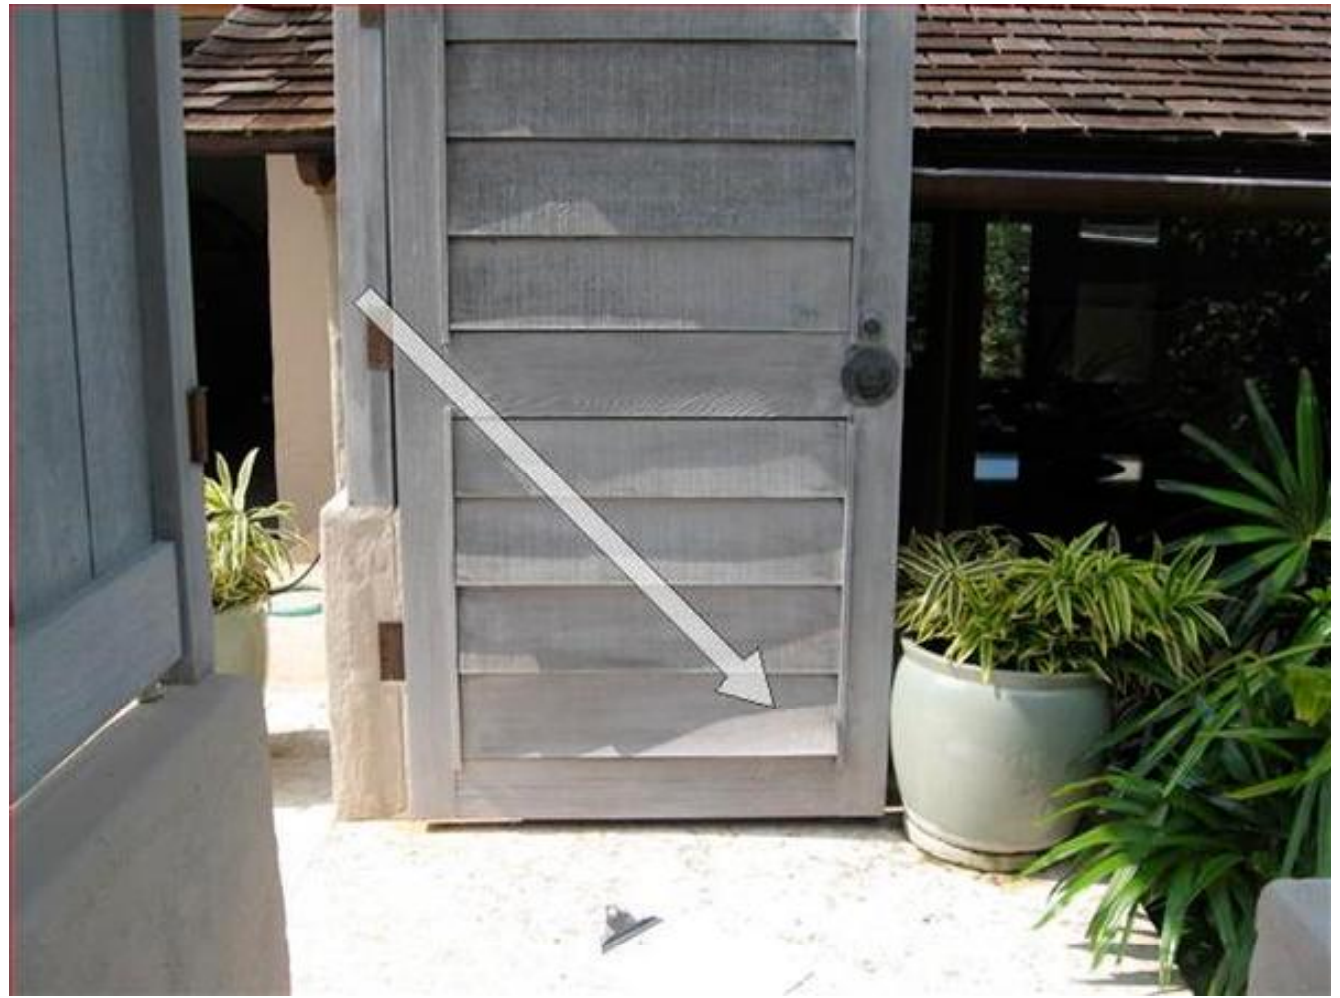
Figure Number 1

Minor repairs may be required at several gates; loose panels, binding latches, weather damage noted. Repair as needed.

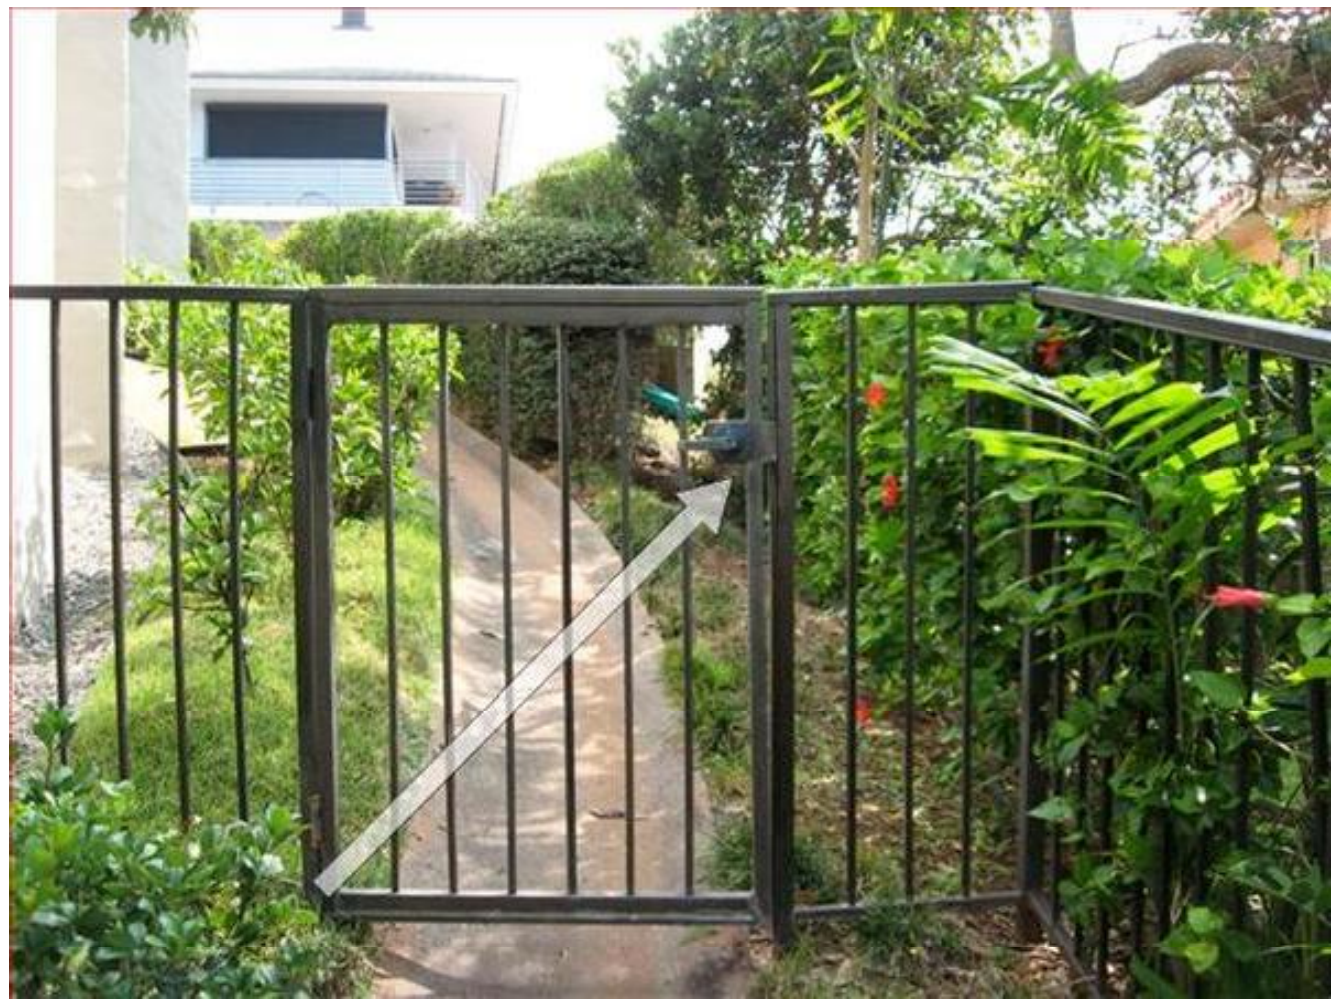
Figure Number 2

Minor repairs may be required at several gates; loose panels, binding latches, weather damage noted. Repair as needed.

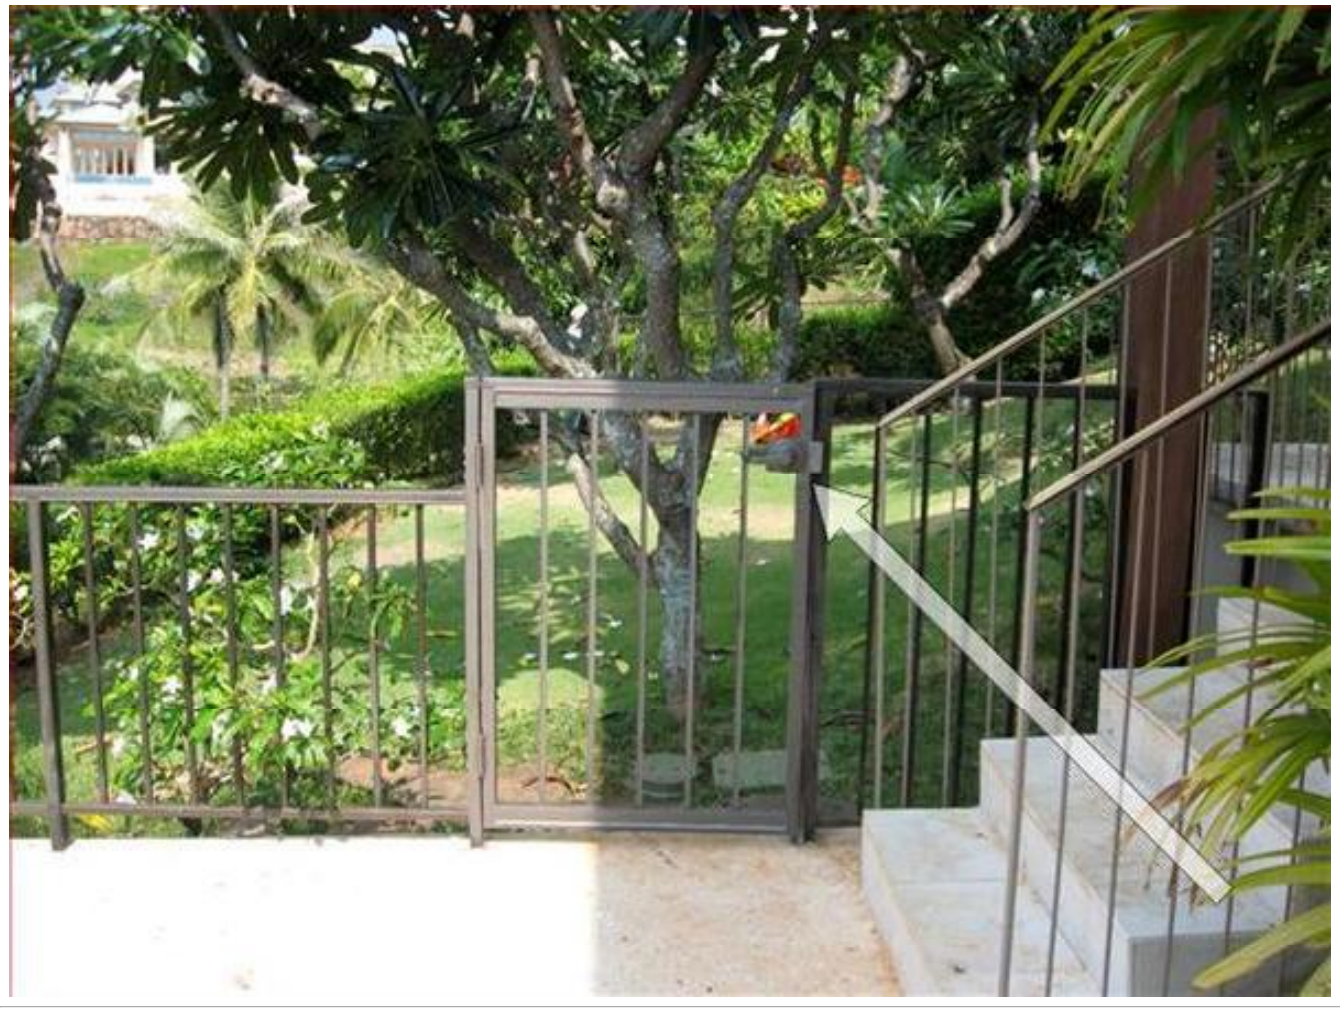
Figure Number 3

Minor repairs may be required at several gates; loose panels, binding latches, weather damage noted. Repair as needed.

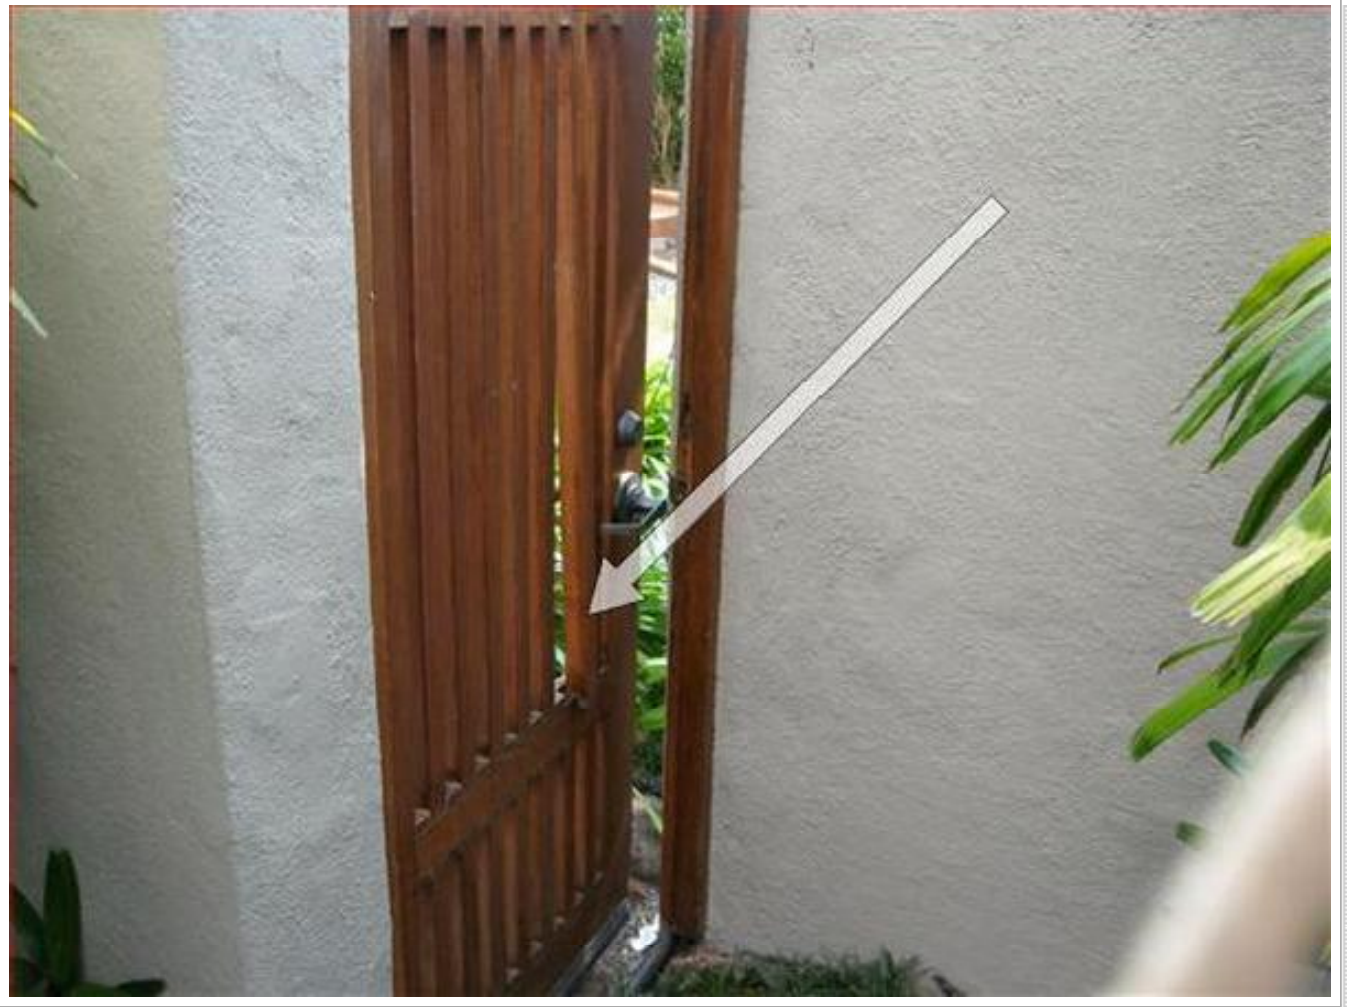
Figure Number 4

Minor repairs may be required at several gates; loose panels, binding latches, weather damage noted. Repair as needed.

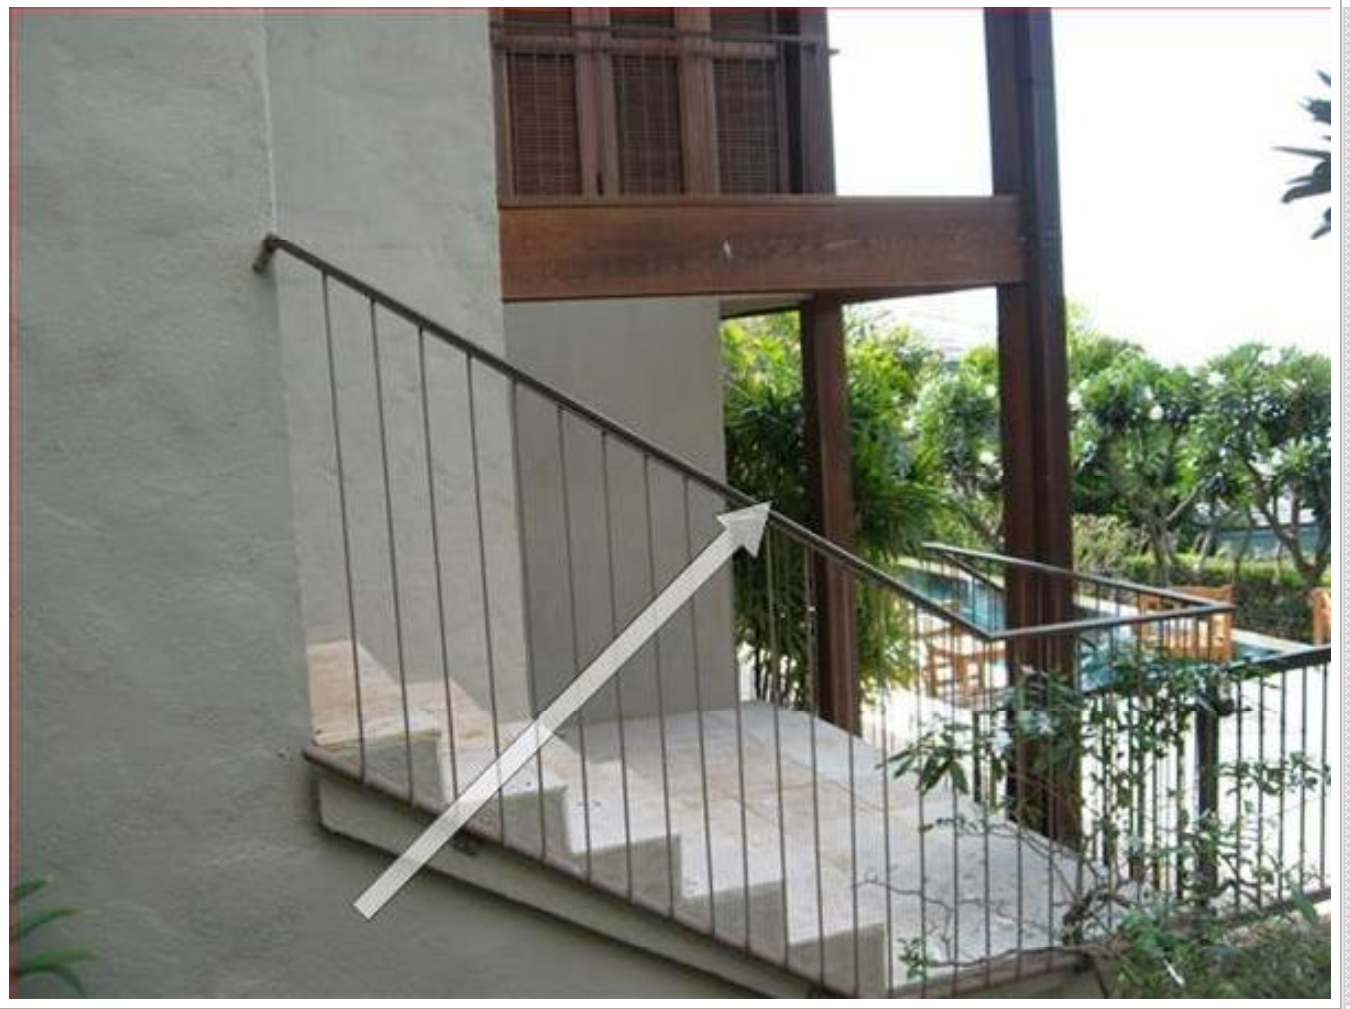
Figure Number 5

Rail caps at right side rear stair are separating from rail. Recommend repairs as needed.

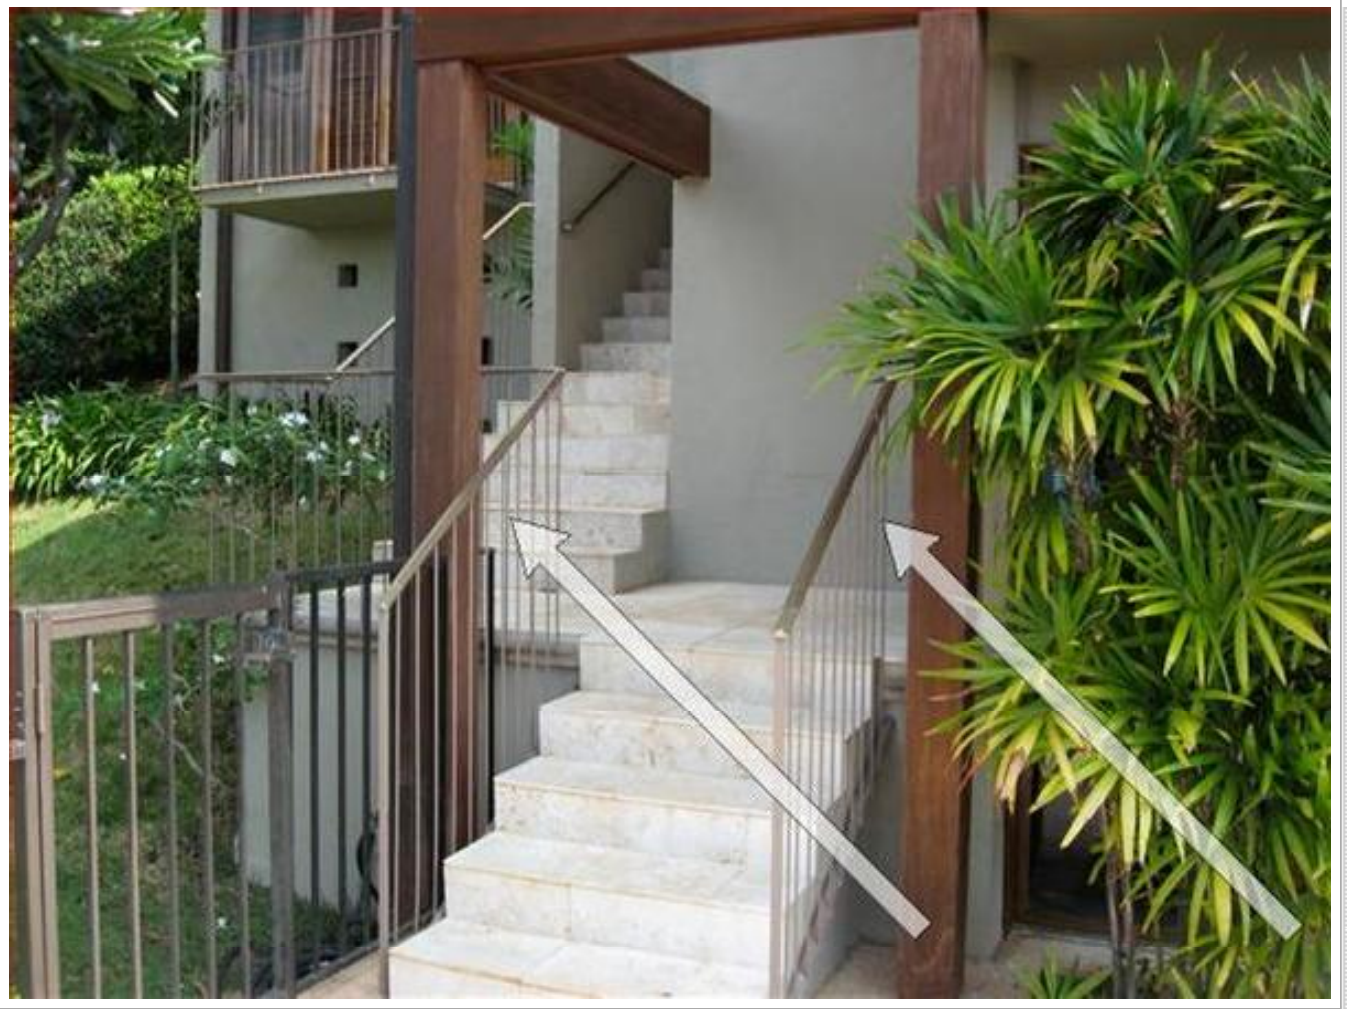
Figure Number 6

Appears the design of the balustrades at the rear right stair creates an inherent instability in the rail. Recommend stabilize as needed.

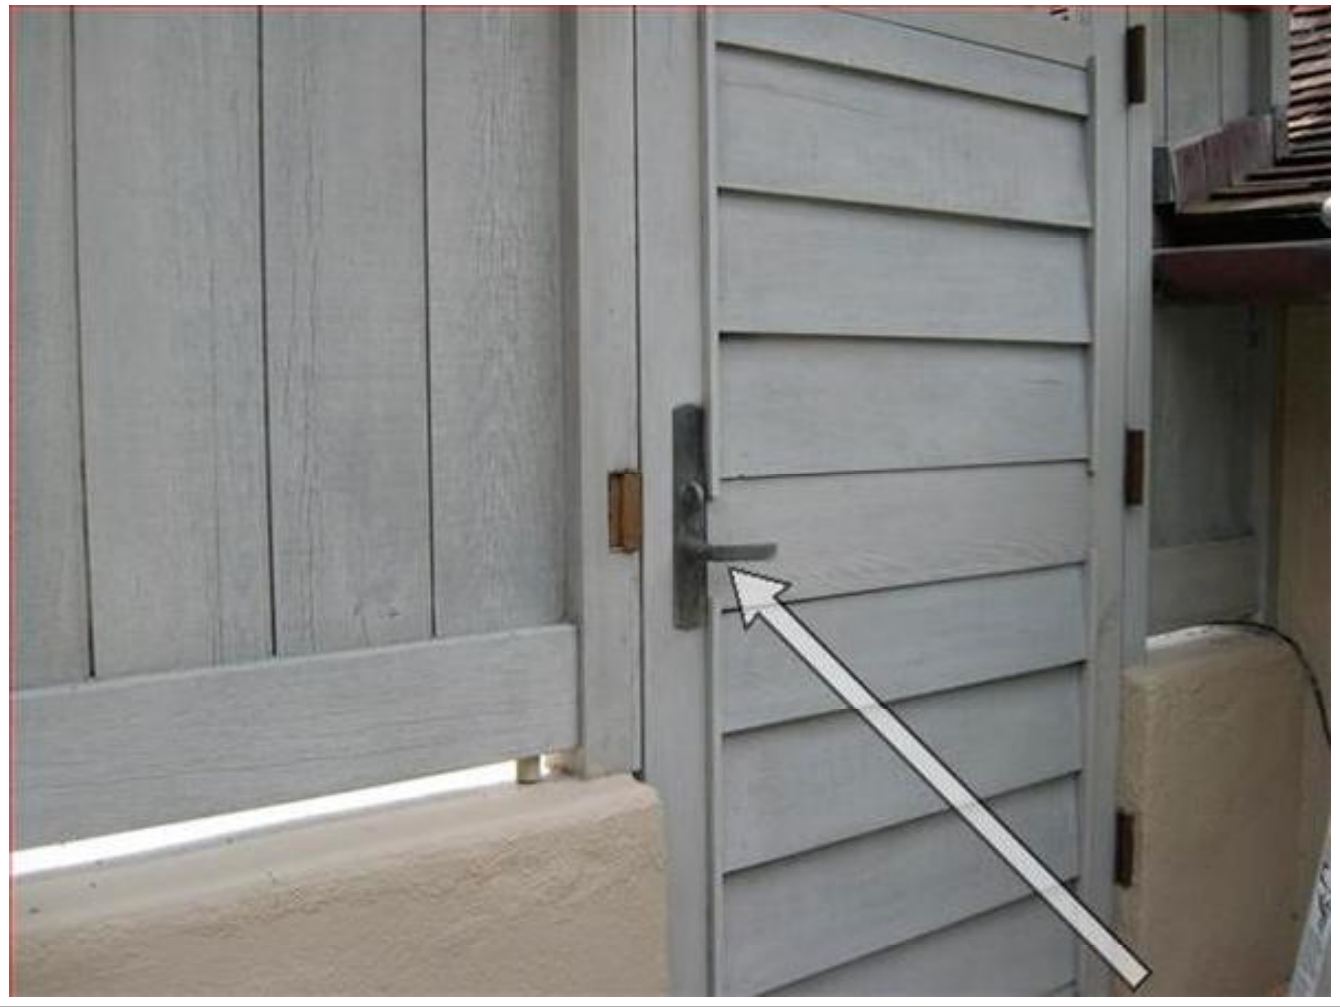
Figure Number 7

Fence	<input checked="" type="checkbox"/> Appears Adequate Gate: Needs Repair Gate Self Closing: Yes
Retaining Wall	<input checked="" type="checkbox"/> Appears Adequate <input checked="" type="checkbox"/> Concrete
General Comments	Proper Grading and water control is essential to prevent water and/or insect damage to siding and/or structure. Constantly damp soil can lead to foundation settlement, cracking and/or failure.
Remarks	<ul style="list-style-type: none"> <li>● Minor repairs may be required at several gates; loose panels, binding latches, weather damage noted. Repair as needed. (See Figure #1) (See Figure #2) (See Figure #3) (See Figure #4)</li> <li>● Rail caps at right side rear stair are separating from rail. Recommend repairs as needed. (See Figure #5)</li> <li>● Appears the design of the balustrades at the rear right stair creates an inherent instability in the rail. Recommend stabilize as needed. (See Figure #6)</li> <li>● Noted lockset at front entry gate in need of minor adjustments/repairs; loose at handle. (See Figure #7)</li> <li>● See Summary Remarks</li> </ul>

Noted lockset at front entry gate in need of minor adjustments/repairs; loose at handle.

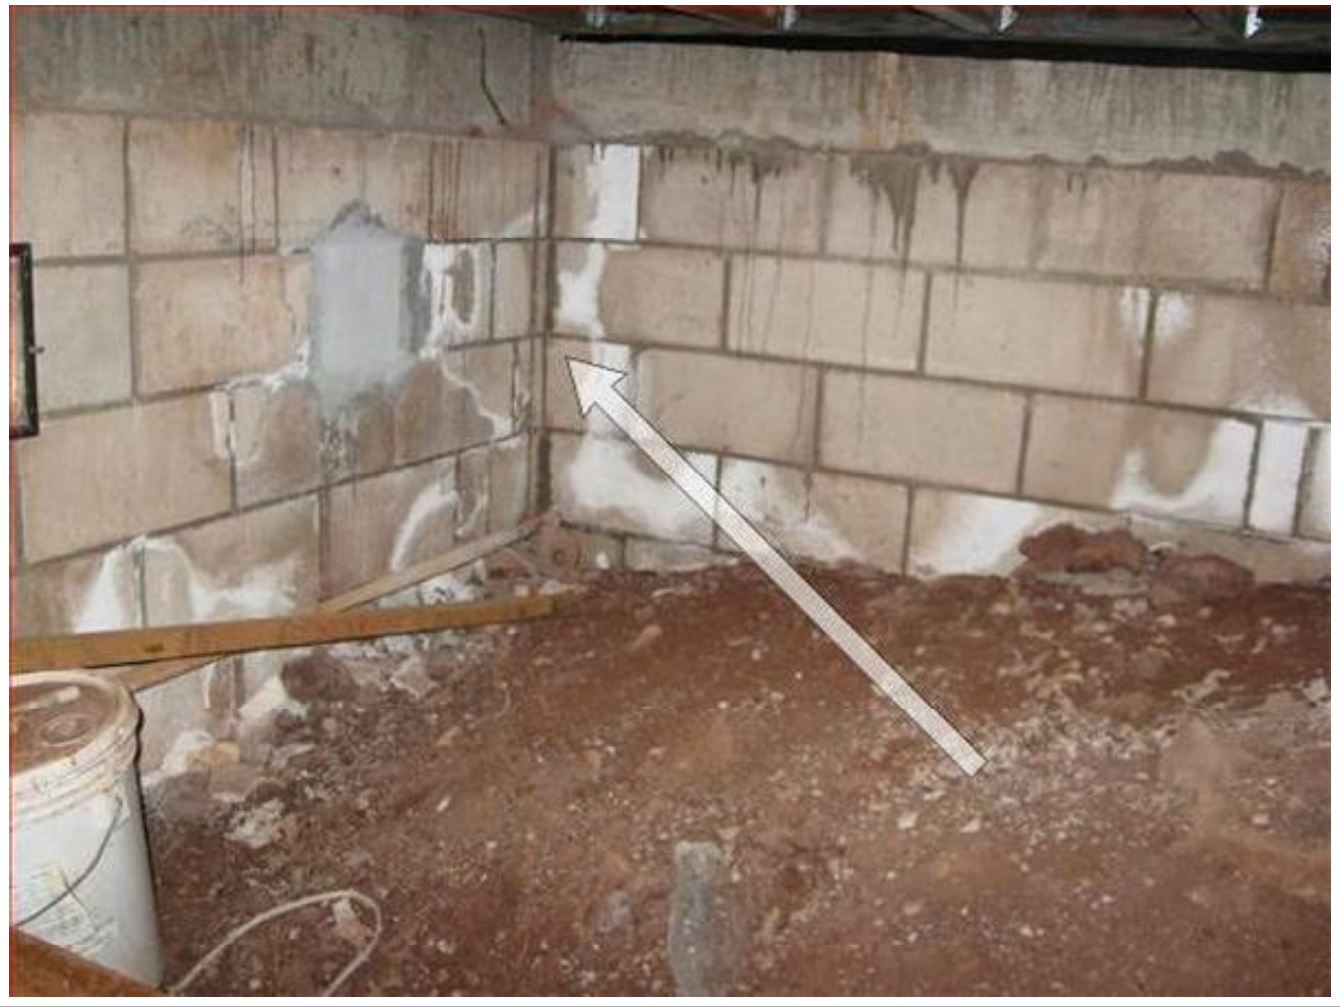
Figure Number 8

Noted efflorescence (white powdery substance) at walls in crawlspace. May indicate migration of moisture through masonry walls. Recommend clean, monitor and repairs as needed.

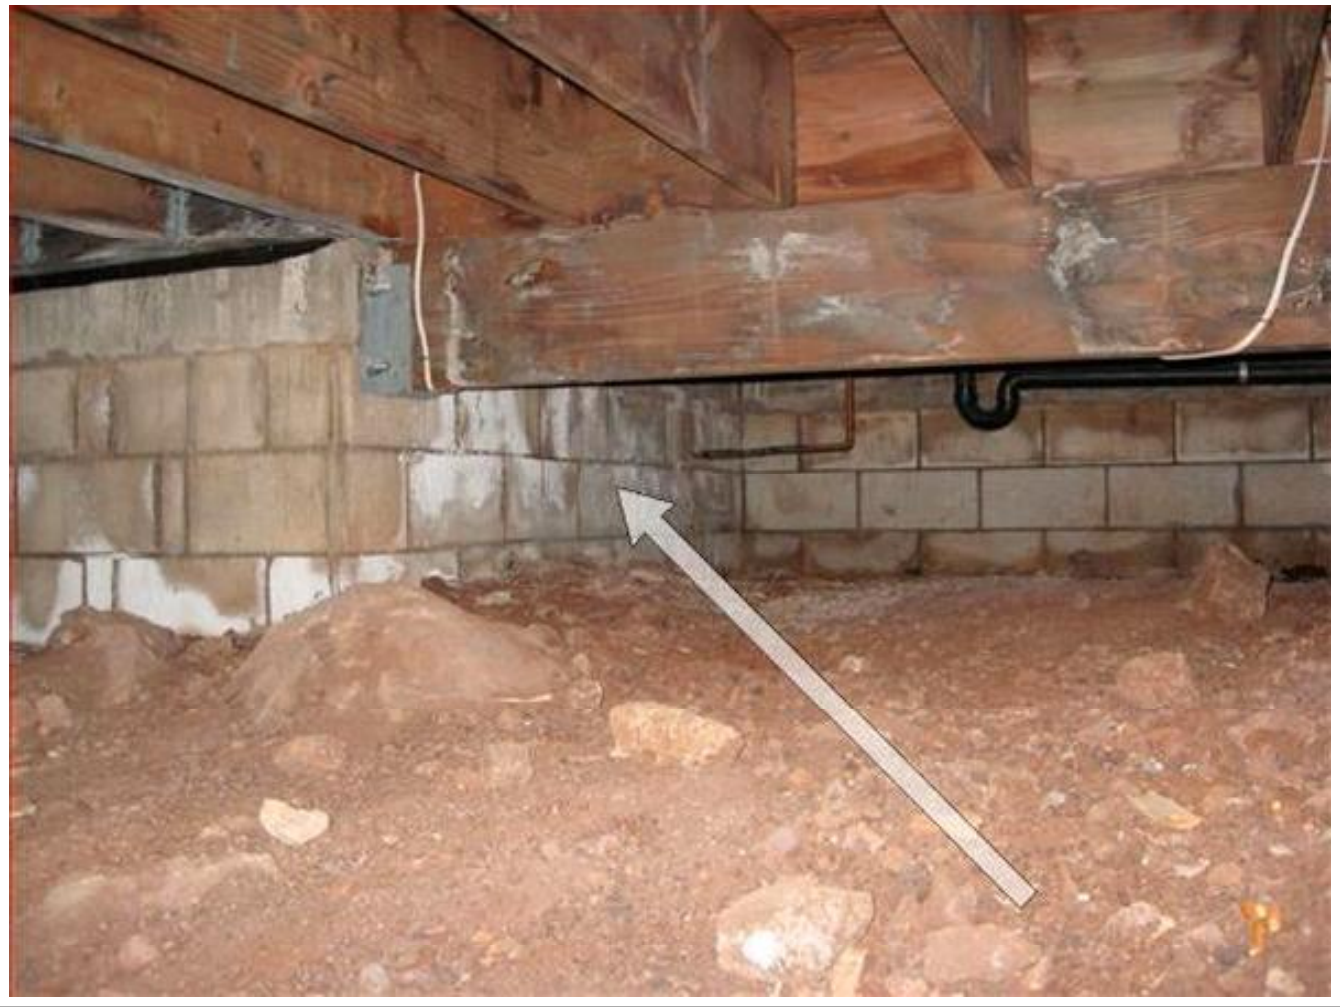
Figure Number 9

Noted efflorescence (white powdery substance) at walls in crawlspace. May indicate migration of moisture through masonry walls. Recommend clean, monitor and repairs as needed.

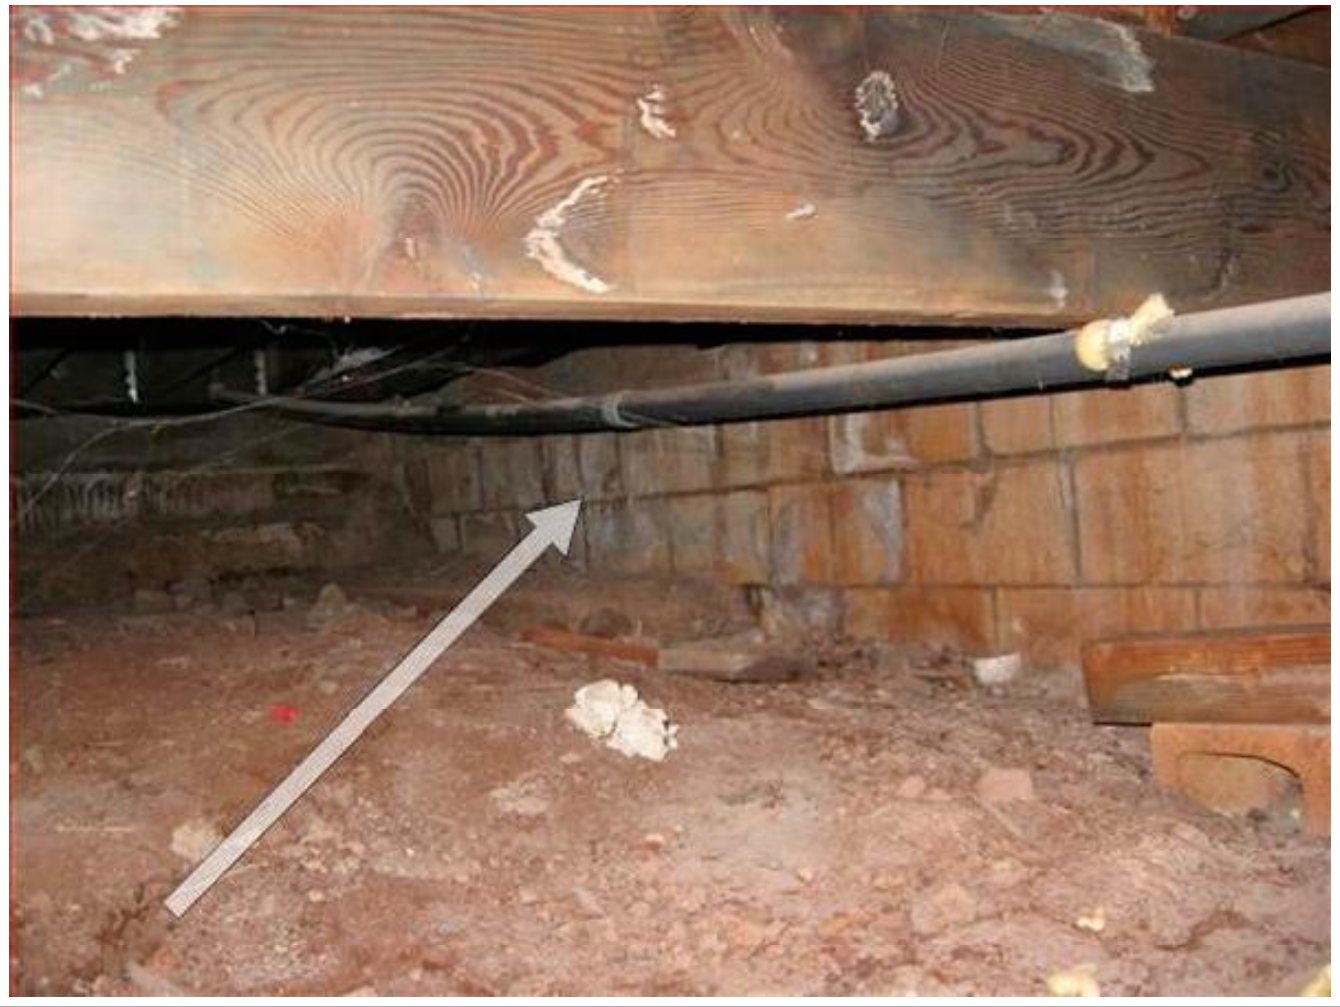
Figure Number 10

Noted efflorescence (white powdery substance) at walls in crawlspace. May indicate migration of moisture through masonry walls. Recommend clean, monitor and repairs as needed.

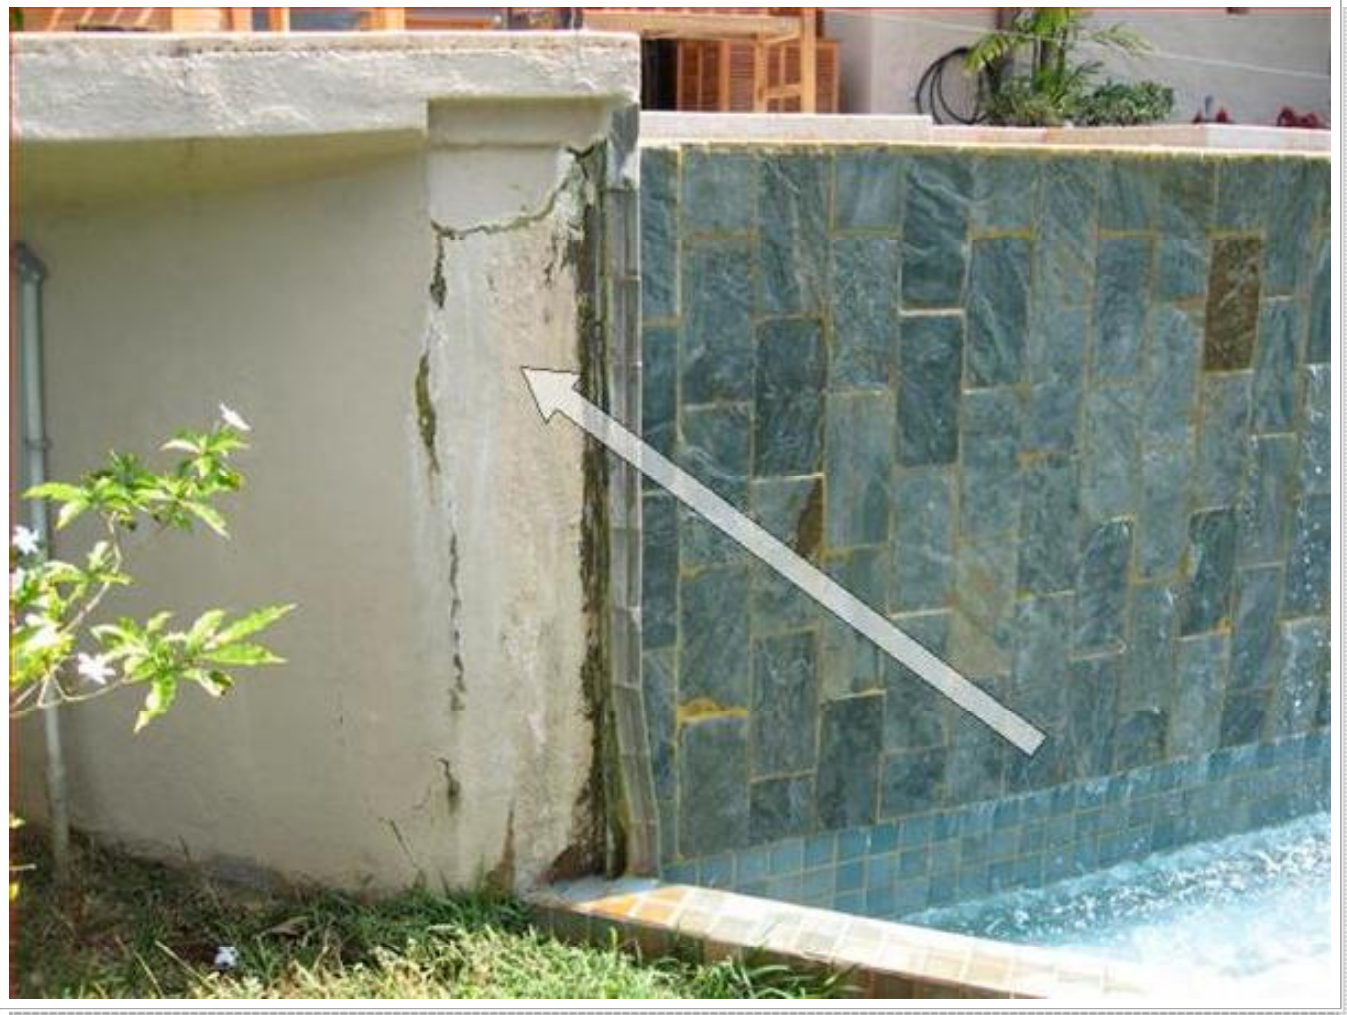
Figure Number 11

Remarks	<ul style="list-style-type: none"> <li>● Noted minor cracking and signs of efflorescence at sides of infinity pool walls. Recommend clean and monitor for repair as needed. (See Figure #11) (See Figure #12)</li> <li>● See Summary Remarks</li> </ul>

Noted minor cracking and signs of efflorescence at sides of infinity pool walls. Recommend clean and monitor for repair as needed.

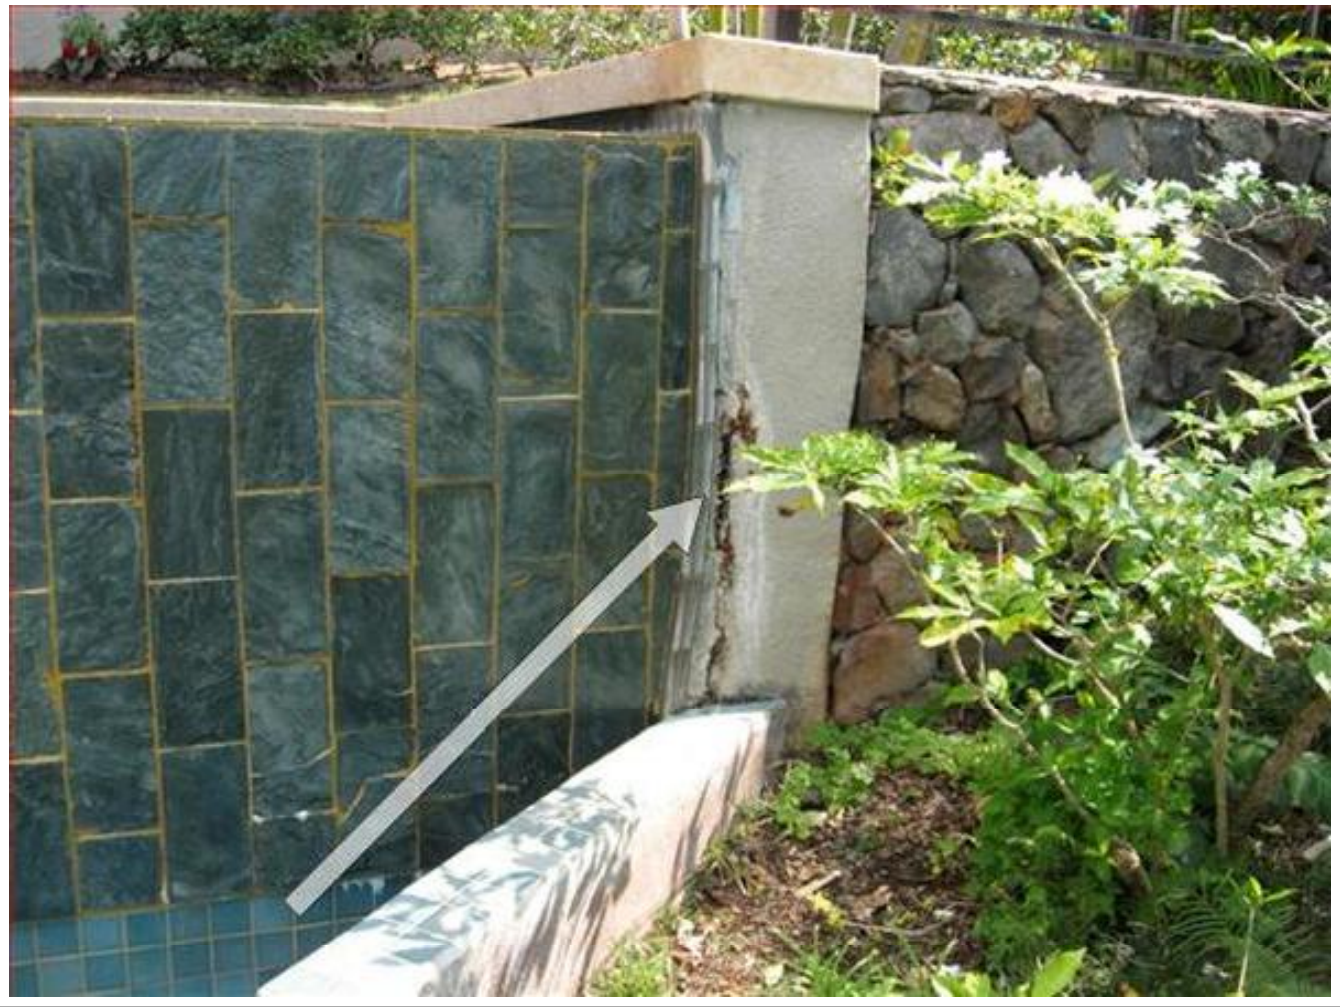
Figure Number 12

Noted minor cracking and signs of efflorescence at sides of infinity pool walls. Recommend clean and monitor for repair as needed.

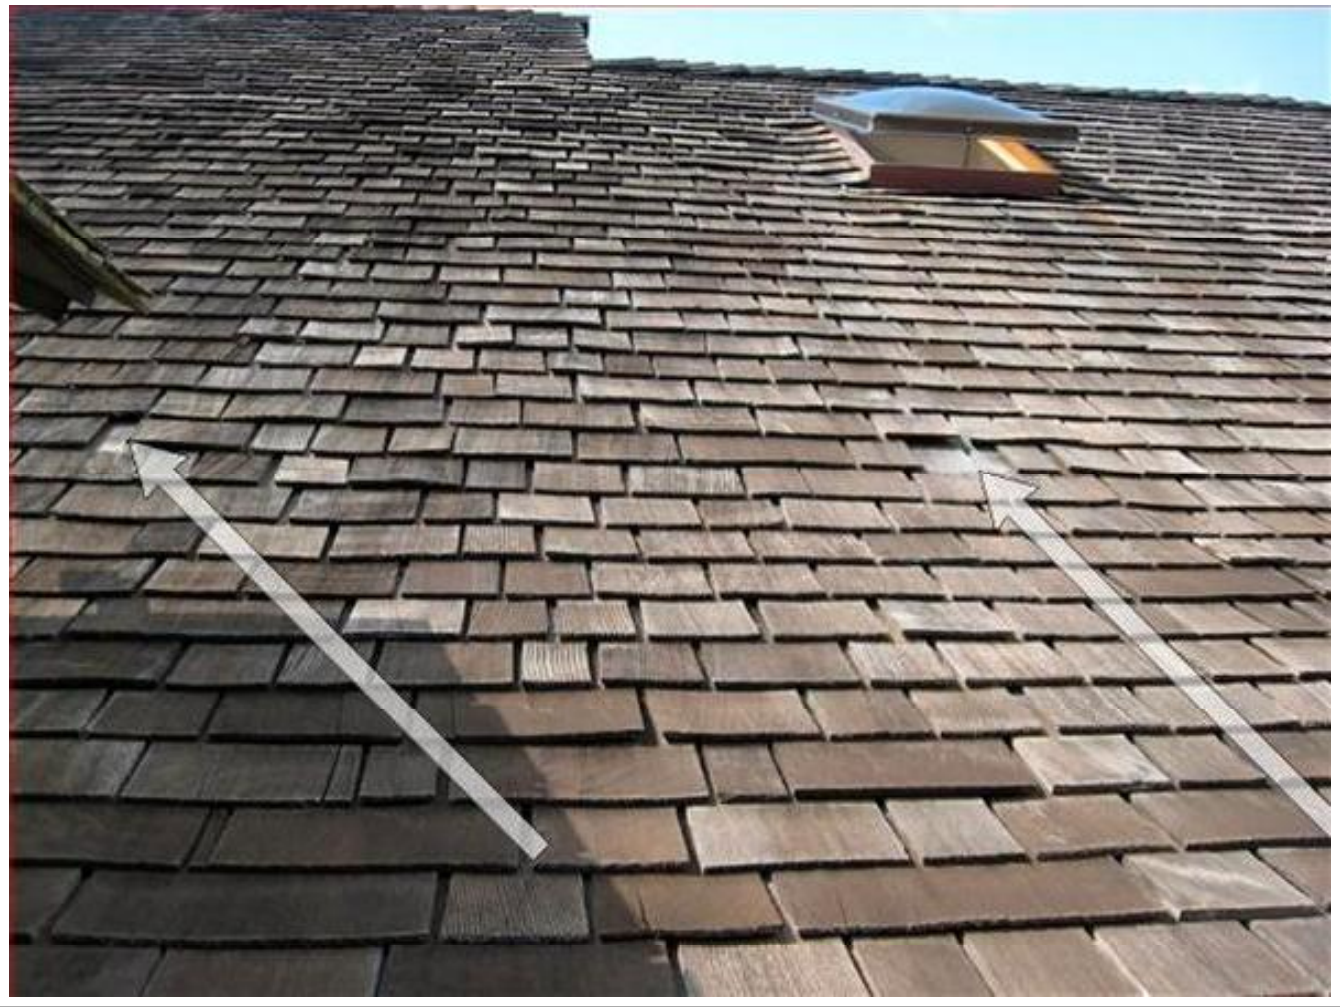
Figure Number 13

Missing shingles noted on various areas of roof. Repair/replace as needed.

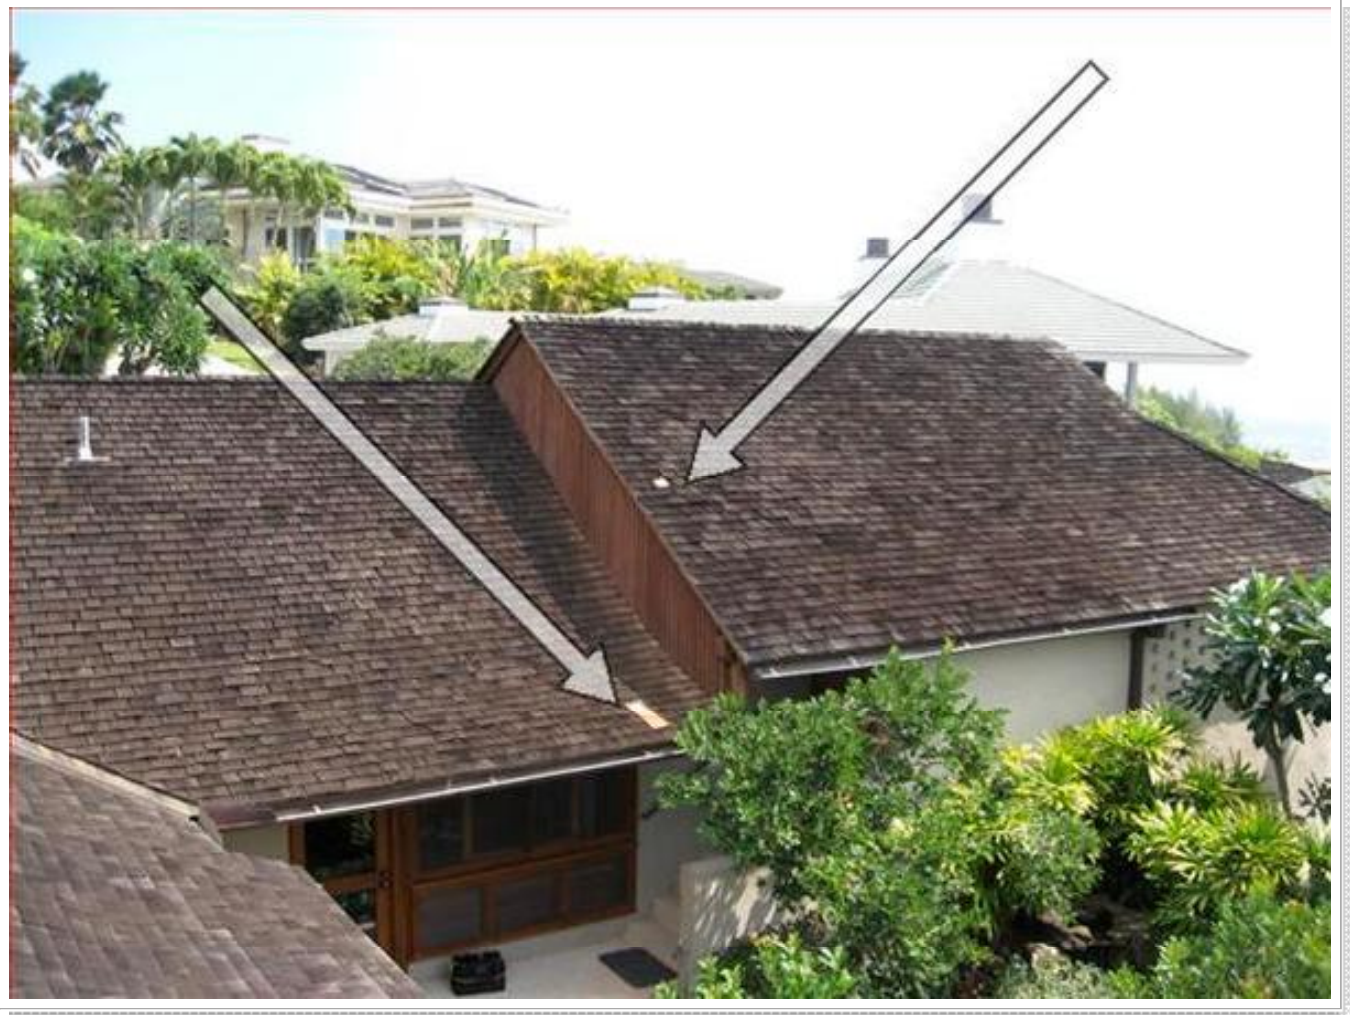
Figure Number 14

Missing shingles noted on various areas of roof. Repair/replace as needed.

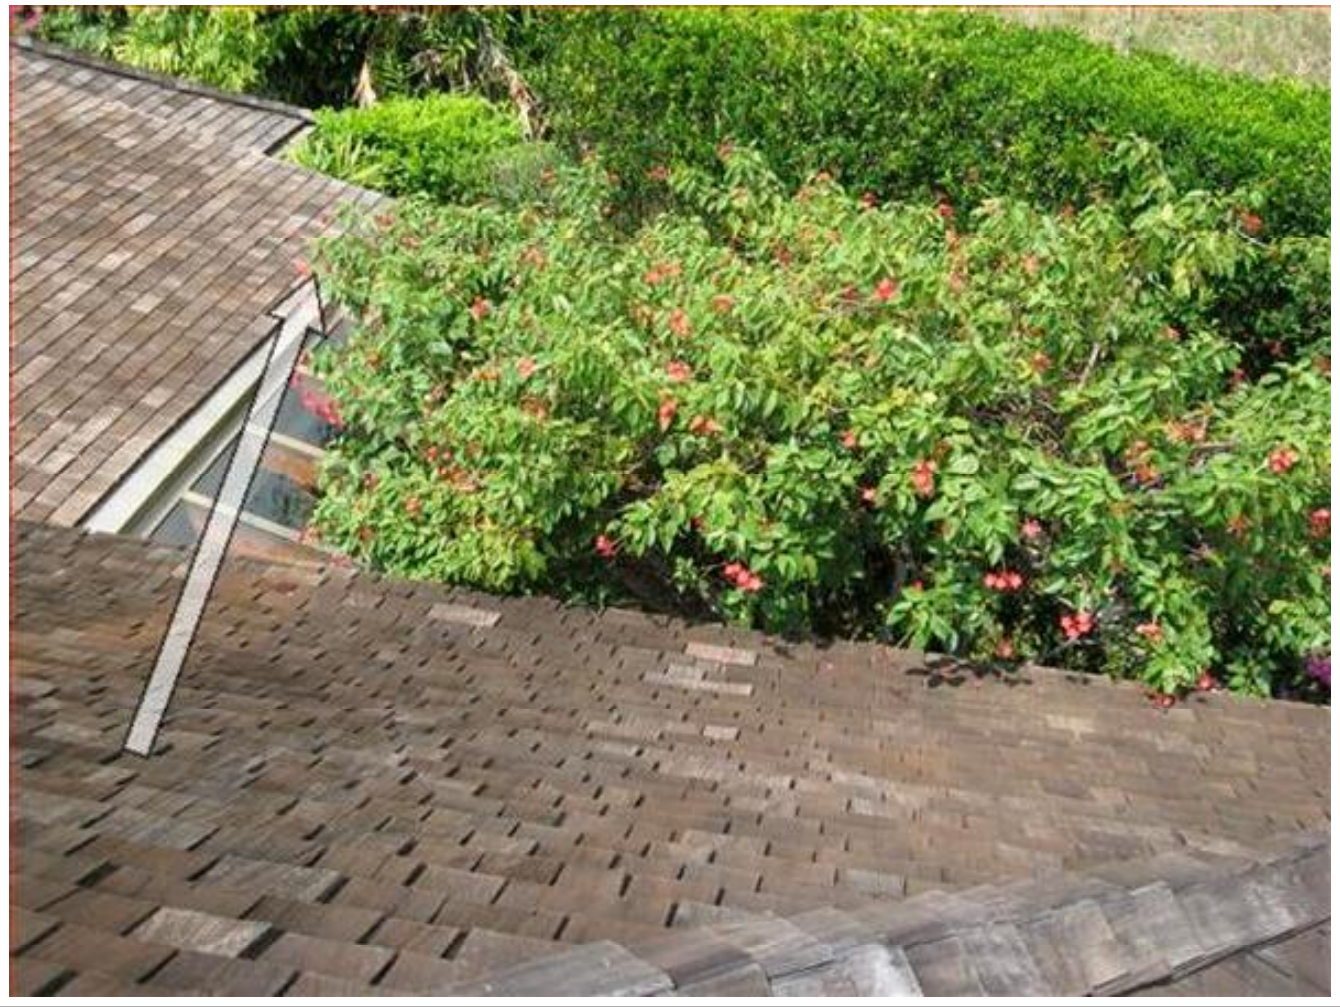
Figure Number 16

Exposed Fasteners Noted At	<input checked="" type="checkbox"/> N/V
General Comments	<p>Any signs of damage,rot,water infiltration,insect damage,settlement,or abnormalities should be repaired. Tree branches should have several inches of clearance from roof/material or damage/infiltration could occur. South/east (windward) facing materials and trim take the most damage from the sun and weather. It is recommended that routine maintenance and upgrades are paid especially to these areas. "Manufacturers' suggested useful life" of roof is represented in parenthesis.</p>
Remarks	<ul style="list-style-type: none"> <li>● Missing shingles noted on various areas of roof. Repair/replace as needed. (See Figure #13) (See Figure #14)</li> <li>● Noted tree branches in contact with roof. Recommend trimming tree from roof edge to extend roof life. (See Figure #15) (See Figure #16)</li> <li>● See Summary Remarks</li> </ul>

Noted tree branches in contact with roof. Recommend trimming tree from roof edge to extend roof life.

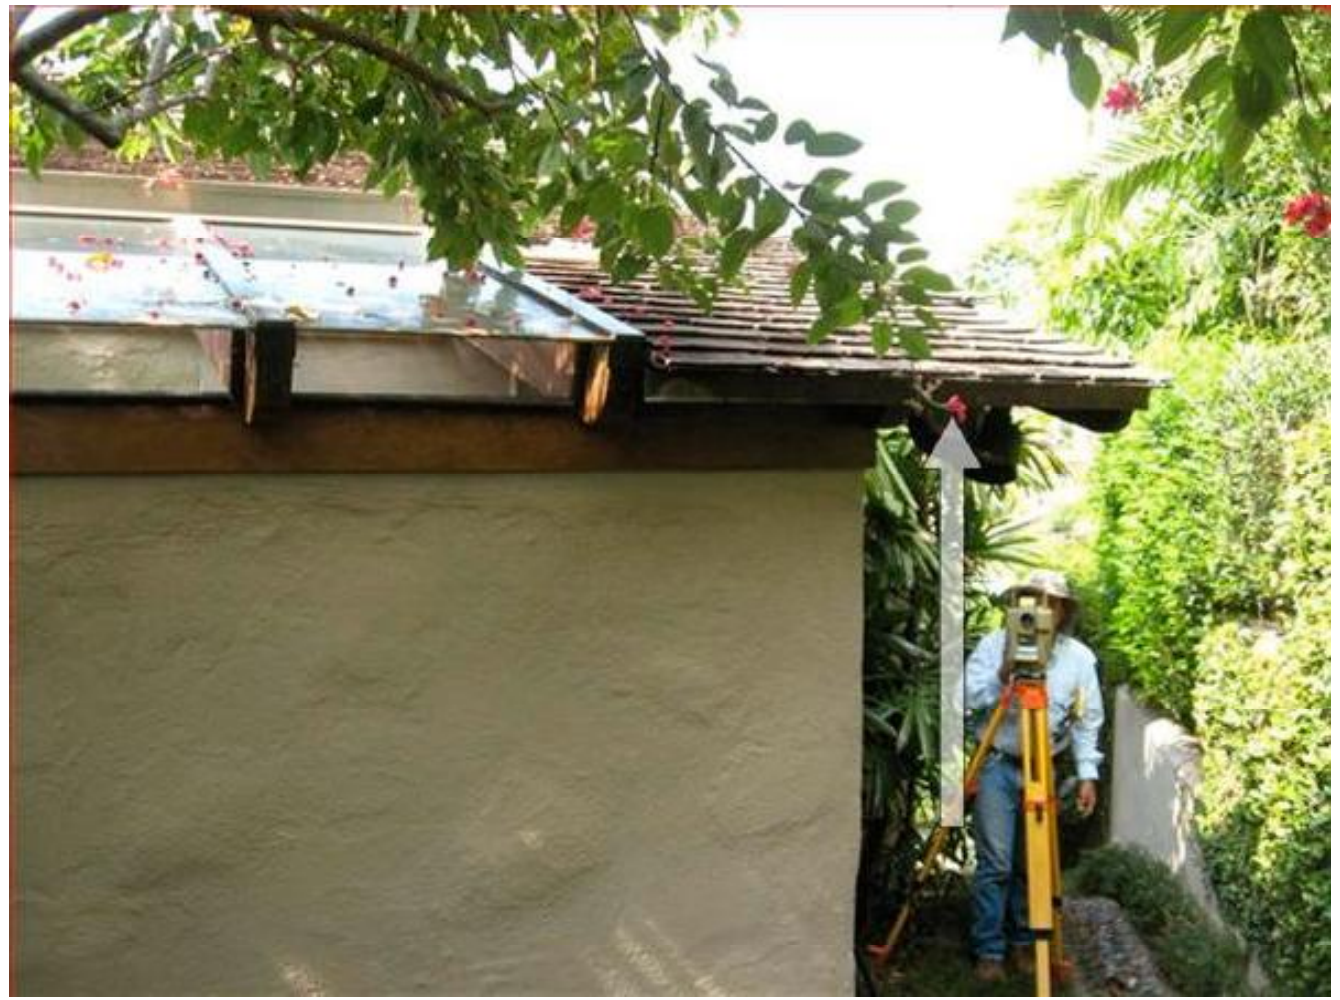
Figure Number 17

Remarks	<ul style="list-style-type: none"> <li>● Low level moisture stains noted (21%) on wood eaves at right exterior eave. Recommend refinish to extend wood life. (See Figure #17)</li> <li>● Unable to verify operation of switch at front right. Recommend verify with seller. (See Figure #18)</li> <li>● Receptacle at middle left exposed conductors and separating from wall. Recommend repairs by qualified electrician as needed. (See Figure #19)</li> <li>● Minor separation noted at wall and structure at left middle of exterior. Recommend repairs as needed and monitor. (See Figure #20)</li> <li>● See Summary Remarks</li> </ul>

Low level moisture stains noted (21%) on wood eaves at right exterior eave. Recommend refinish to extend wood life.
