# ARCHITECH

HOME INSPECTION SYSTEMS, LLC

123 Anykine Dr, Honolulu , Hawaii 96888

**Inspection Date:**  
11/12/2008  
**Prepared For:**  
Ver E. Important  
**Report Number:**  
20081014-BN-1  
**Inspector:**  
Bryan Naff

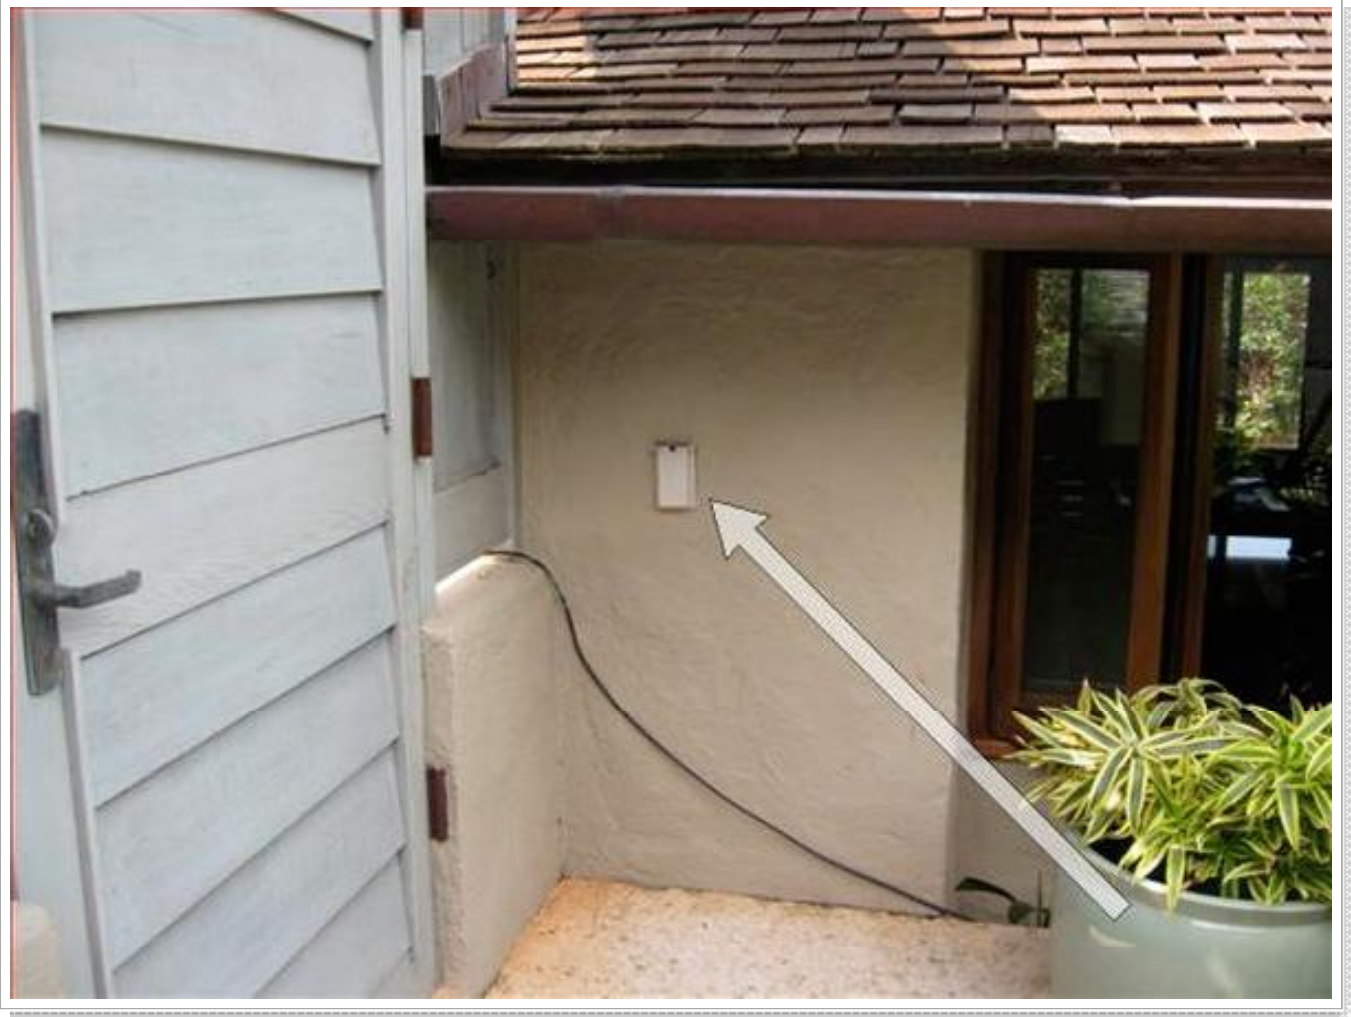
Figure Number 18

Remarks	<ul style="list-style-type: none"> <li>● Low level moisture stains noted (21%) on wood eaves at right exterior eave. Recommend refinish to extend wood life. (See Figure #17)</li> <li>● Unable to verify operation of switch at front right. Recommend verify with seller. (See Figure #18)</li> <li>● Receptacle at middle left exposed conductors and separating from wall. Recommend repairs by qualified electrician as needed. (See Figure #19)</li> <li>● Minor separation noted at wall and structure at left middle of exterior. Recommend repairs as needed and monitor. (See Figure #20)</li> <li>● See Summary Remarks</li> </ul>

Unable to verify operation of switch at front right. Recommend verify with seller.

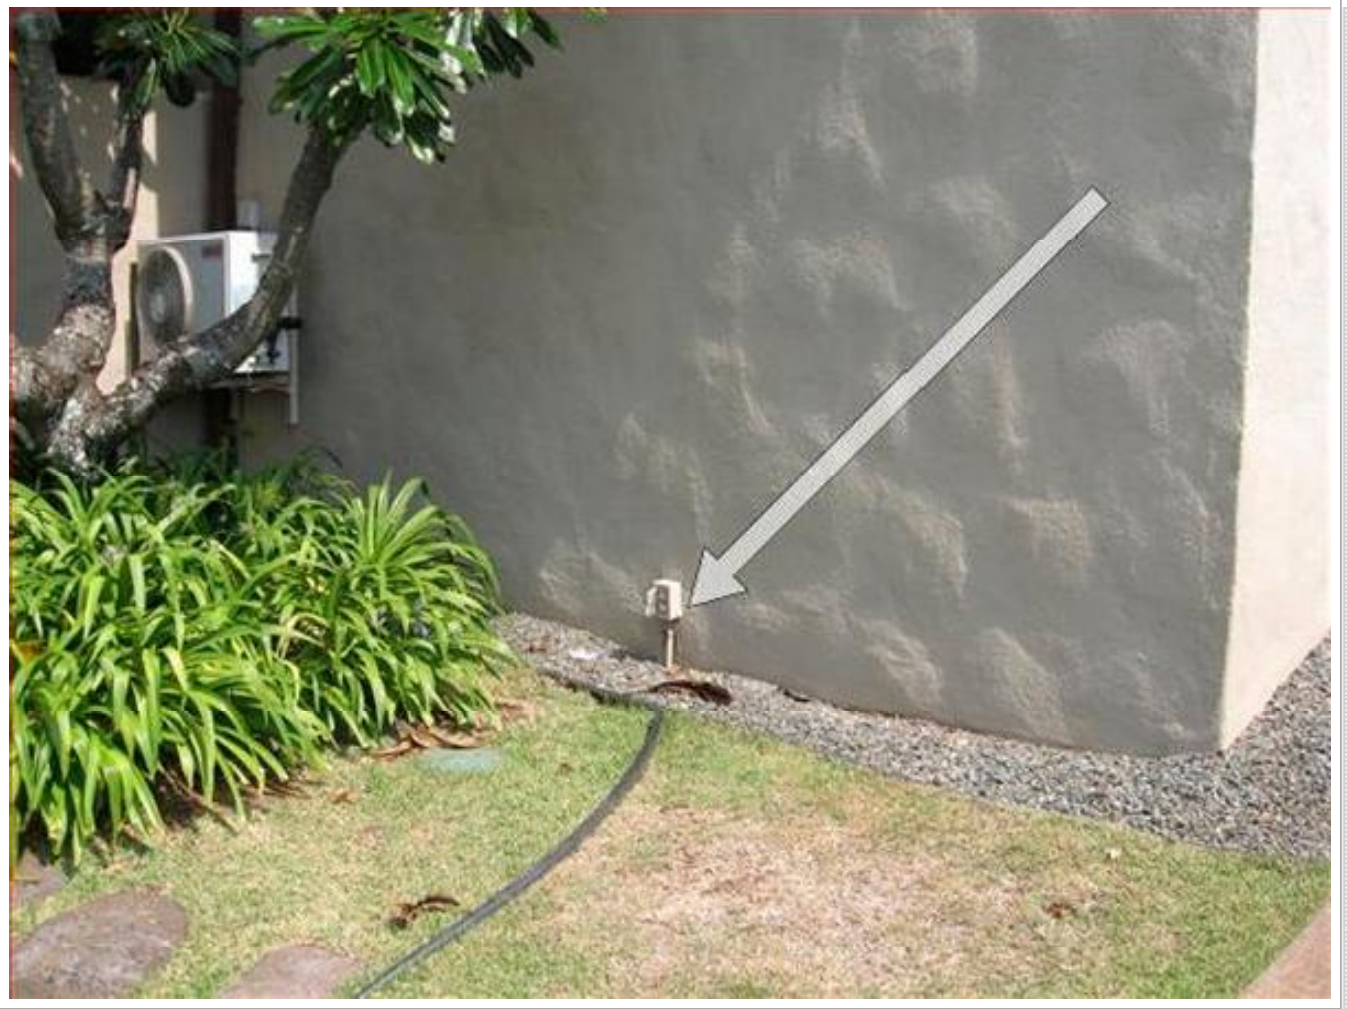
Figure Number 19

Receptacle at middle left exposed conductors and separating from wall. Recommend repairs by qualified electrician as needed.

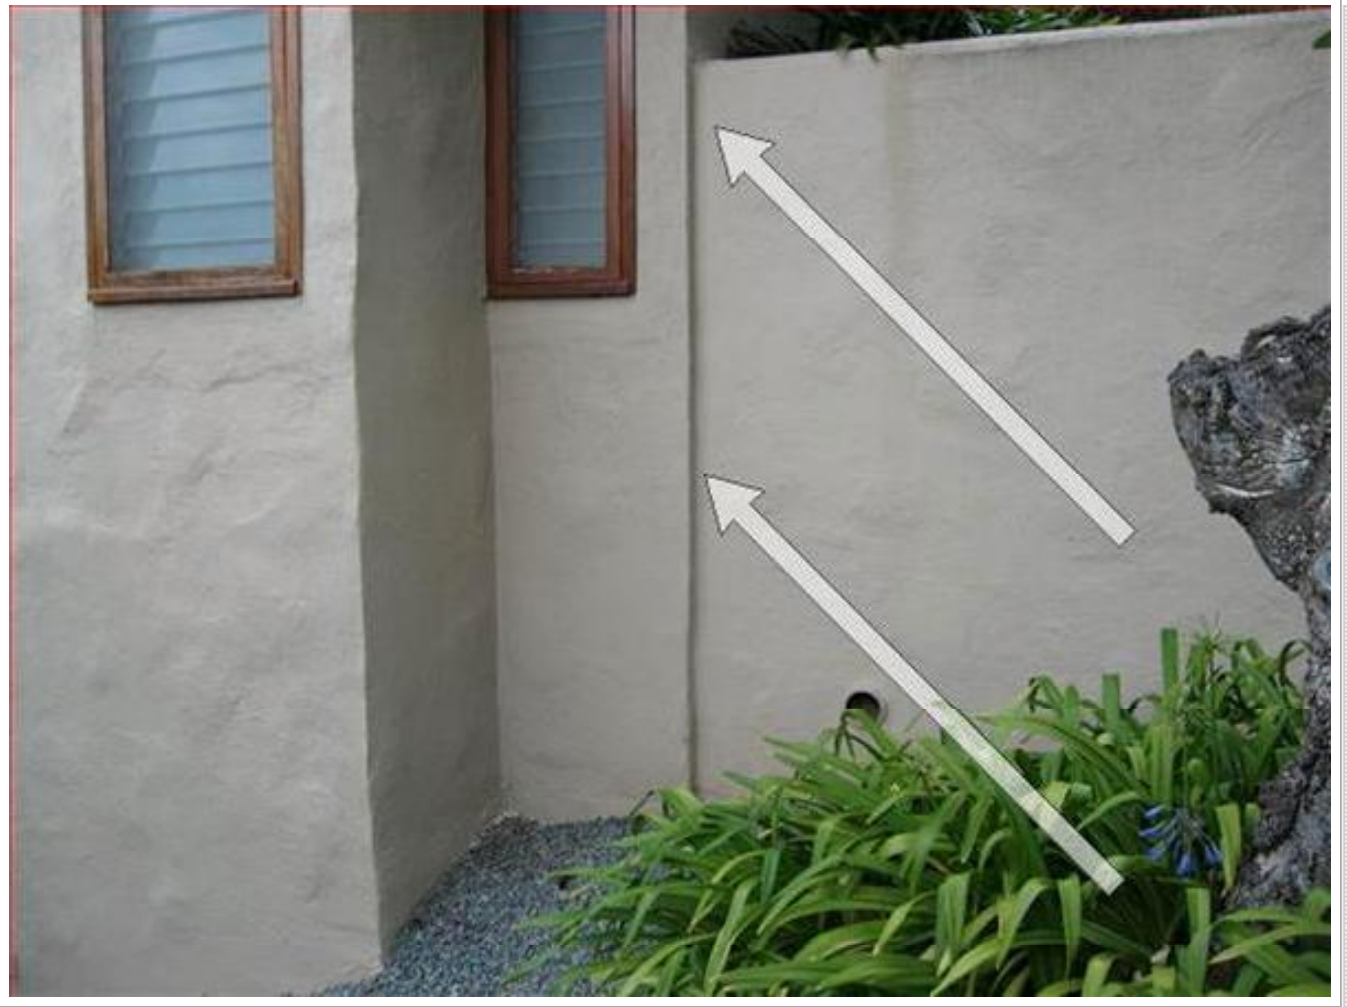
Figure Number 20

Minor separation noted at wall and structure at left middle of exterior. Recommend repairs as needed and monitor.

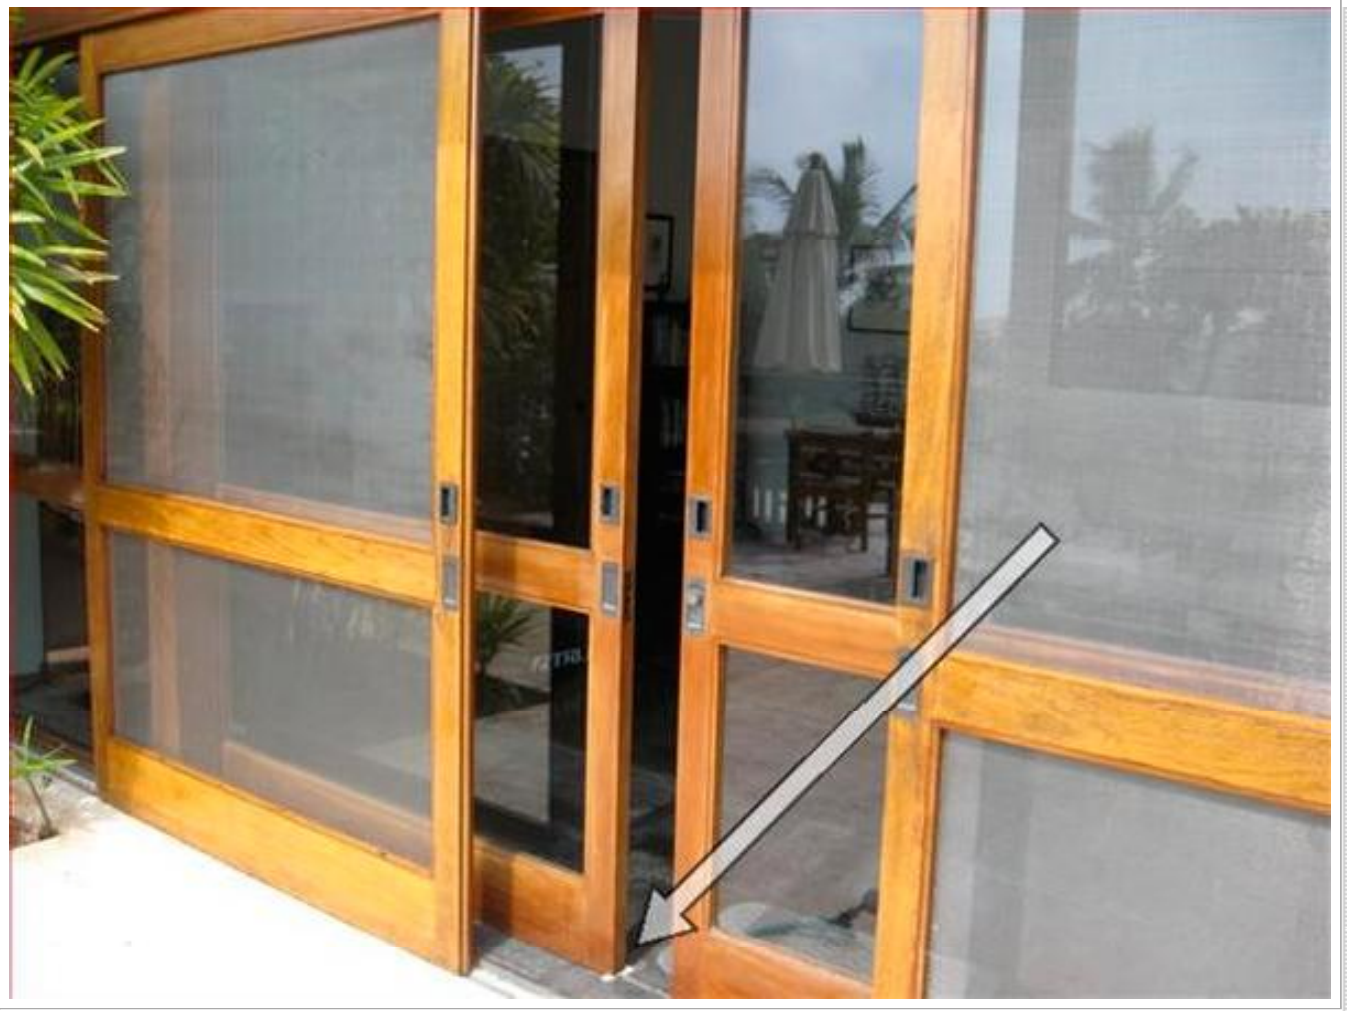
Figure Number 21

Remarks	<ul style="list-style-type: none"> <li>Minor adjustment/repairs may be required at sliding doors at pool. (See Figure #21)</li> <li>See Summary Remarks</li> </ul>

Minor adjustment/repairs may be required at sliding doors at pool.

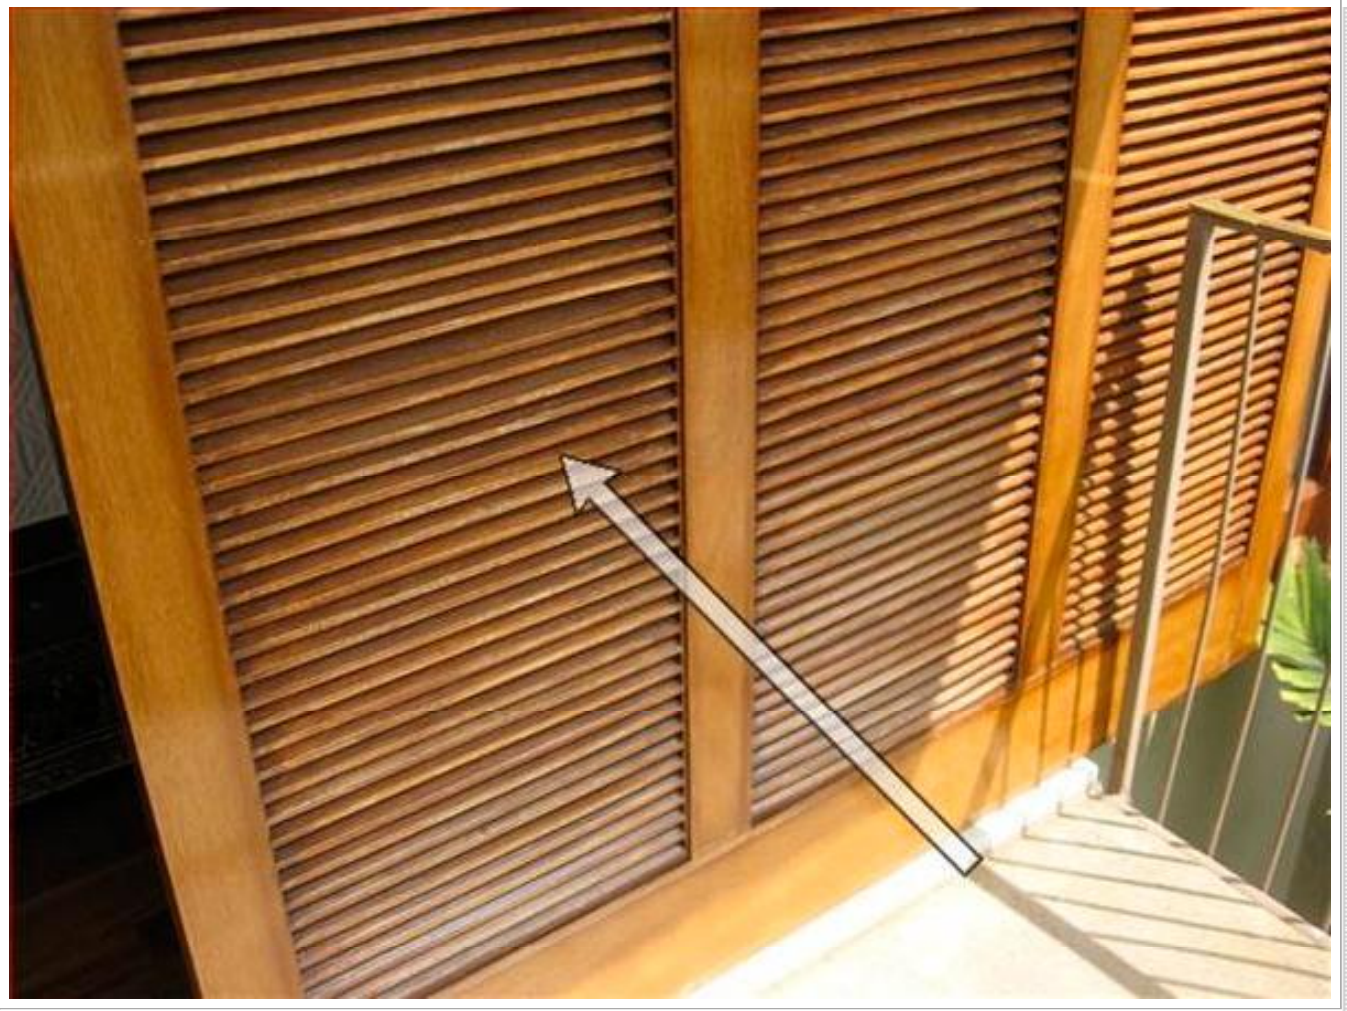
Figure Number 22

Remarks	<ul style="list-style-type: none"> <li>Recommend refinish exterior lanai doors of master bedroom to extend life of wood. (See Figure #22)</li> <li>Unable to open/operate lockset of lanai doors of 2nd bedroom. Recommend minor adjustments as needed to operate. (See Figure #23)</li> <li>Noted minor cupping at wood floor planks at front entry. No active moisture noted. Recommend repairs as needed. (See Figure #24)</li> </ul>

Recommend refinish exterior lanai doors of master bedroom to extend life of wood.

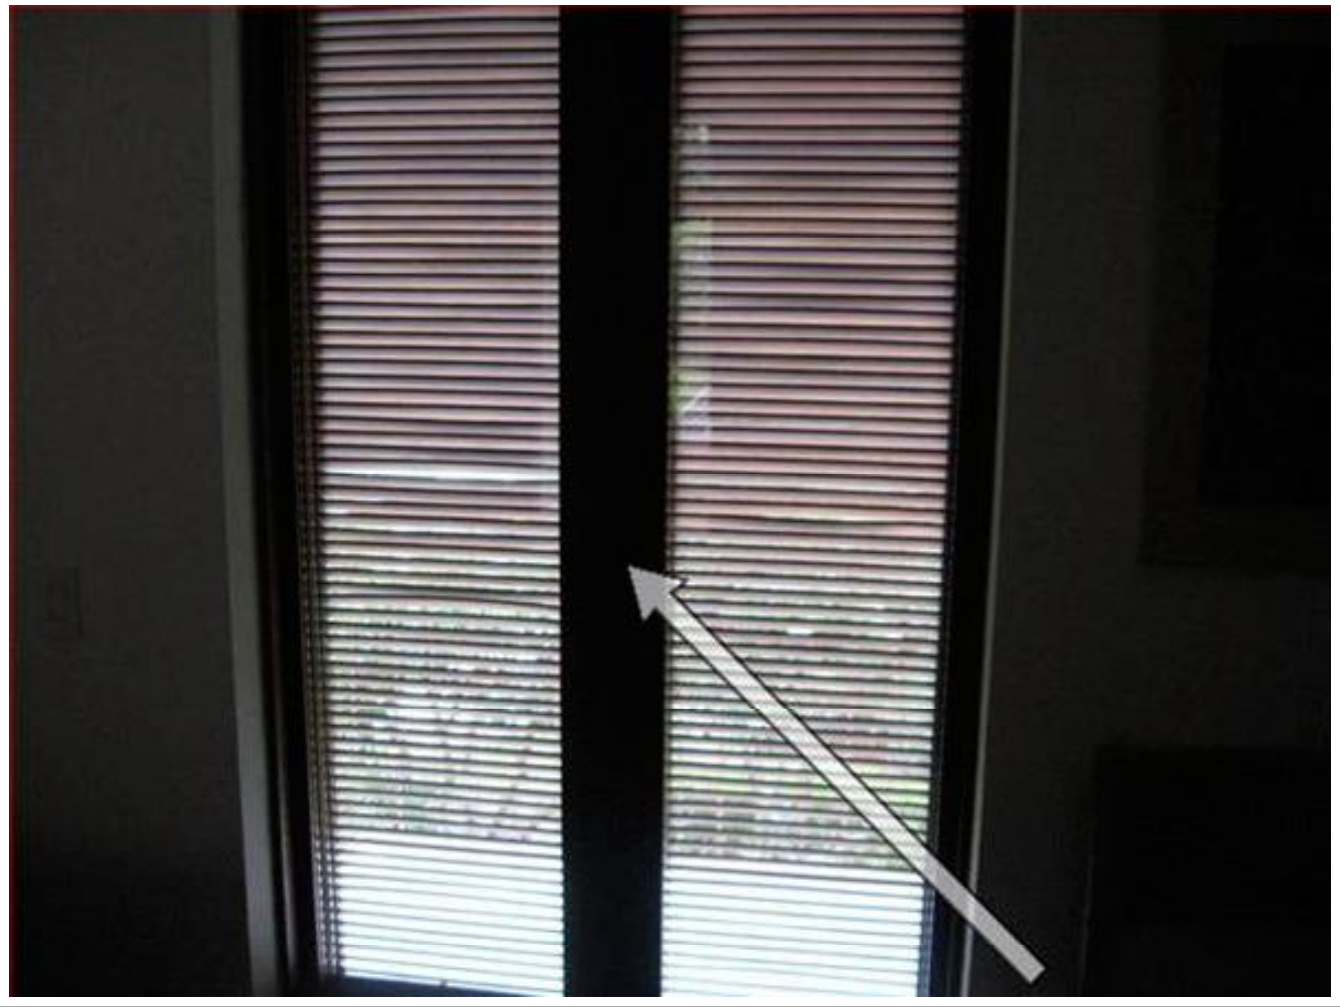
Figure Number 23

Unable to open/operate lockset of lanai doors of 2nd bedroom. Recommend minor adjustments as needed to operate.

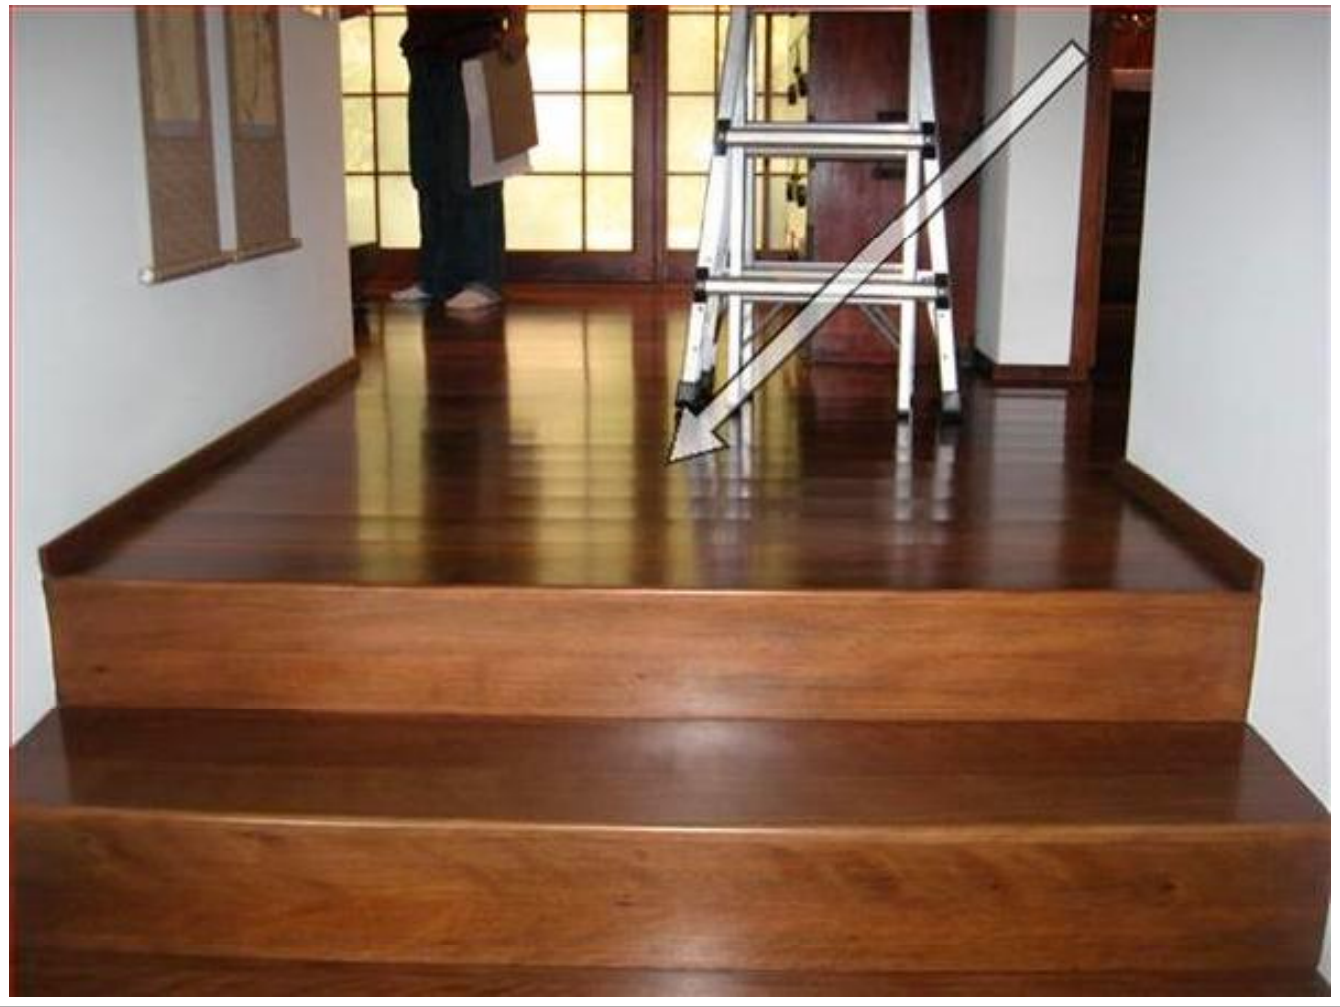
Figure Number 24

Noted minor cupping at wood floor planks at front entry. No active moisture noted. Recommend repairs as needed.

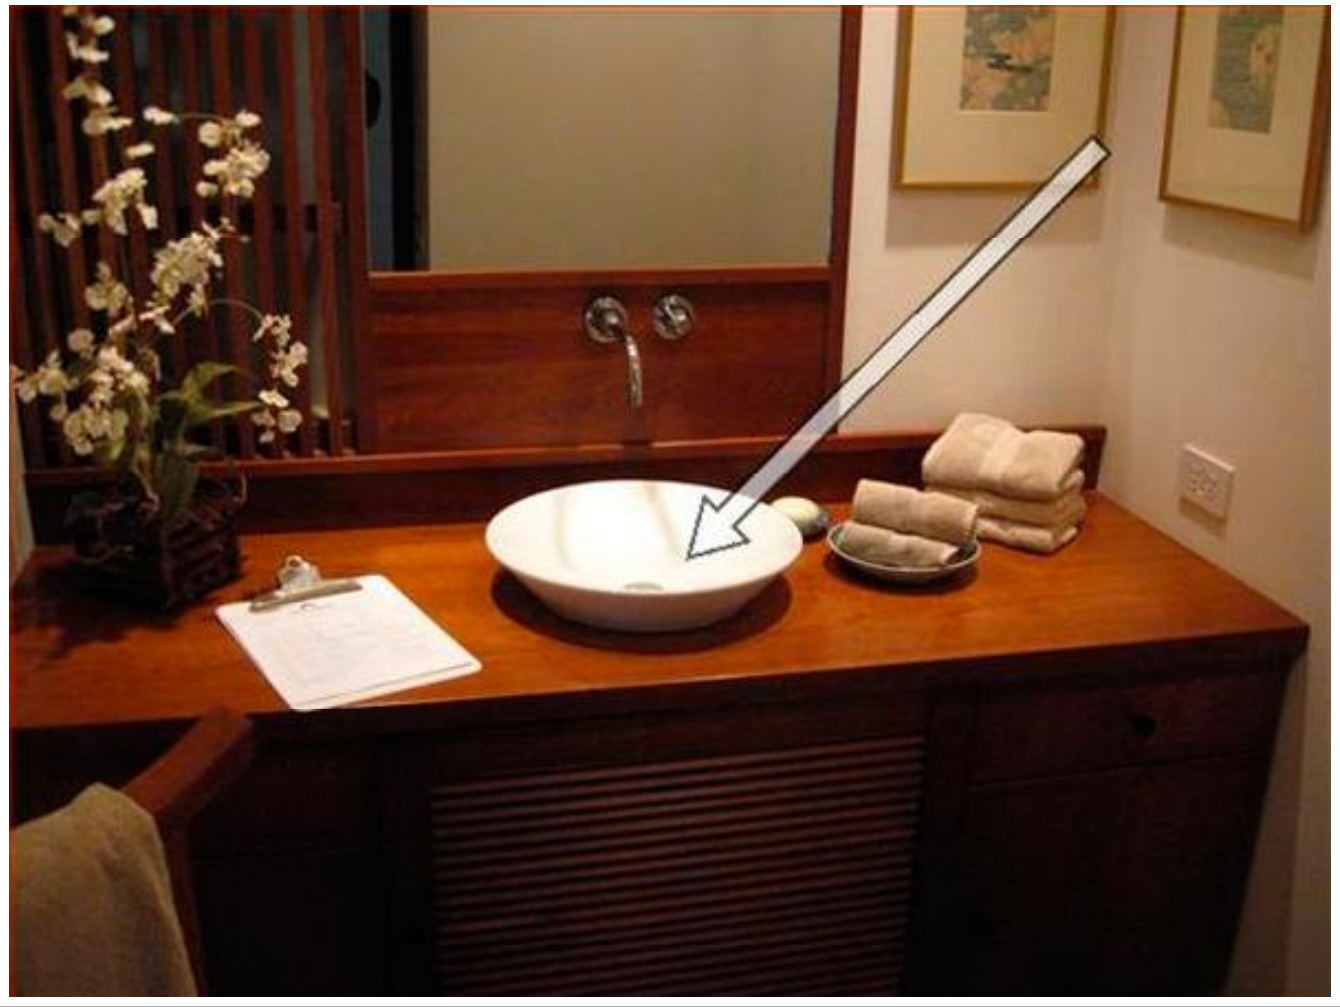
Figure Number 25

Remarks	<ul style="list-style-type: none"> <li>Noted sink in hall bath slow to drain. May indicate minor clog. Repair as needed. (See Figure #25)</li> <li>See Summary Remarks</li> </ul>

Noted sink in hall bath slow to drain. May indicate minor clog. Repair as needed.

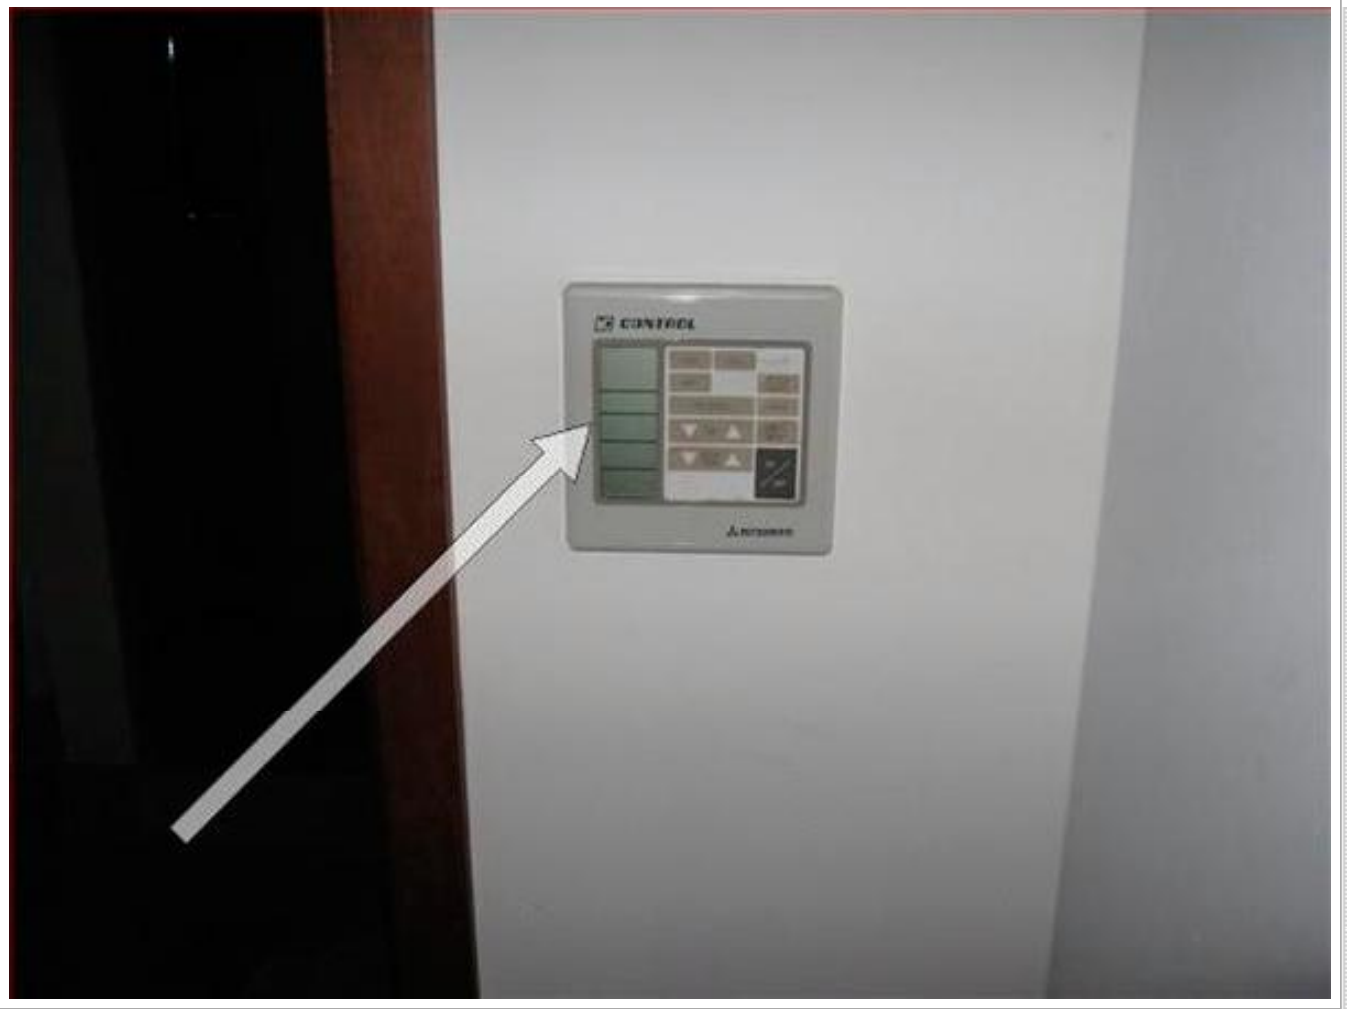
Figure Number 26

Cooling Unit # 4	<input checked="" type="checkbox"/> Appears Adequate Location: Left side Capacity: 1 ton Manufacturer: Mitsubishi MFD: 2002 S/N: label not visible  Air Handler: Supply: 64f Return: 76f <input checked="" type="checkbox"/> Inadequate Differential
Condensate	<input checked="" type="checkbox"/> Appears Adequate
General Comments	Heat pumps and Air Conditioners are checked for operation and no remaining life expectancy or warranty is implied. Heat pumps and Air conditioners have an average life expectancy of 8 to 12 years. Client is advised to have a service check by HVAC certified professional on older units.
Remarks	<ul style="list-style-type: none"> <li>Recommend having all A/C units serviced and maintained by qualified HVAC professional for proper operation; noted low differential at supply/return air of all units. This may indicate low freon or other issues. Air handlers in attic inaccessible by inspector.</li> <li>A/C control panel in rear right bedroom not operational at time of inspection. Recommend verify operation with seller. (See Figure #26)</li> <li>See Summary Remarks</li> </ul>

A/C control panel in rear right bedroom not operational at time of inspection. Recommend verify operation with seller.

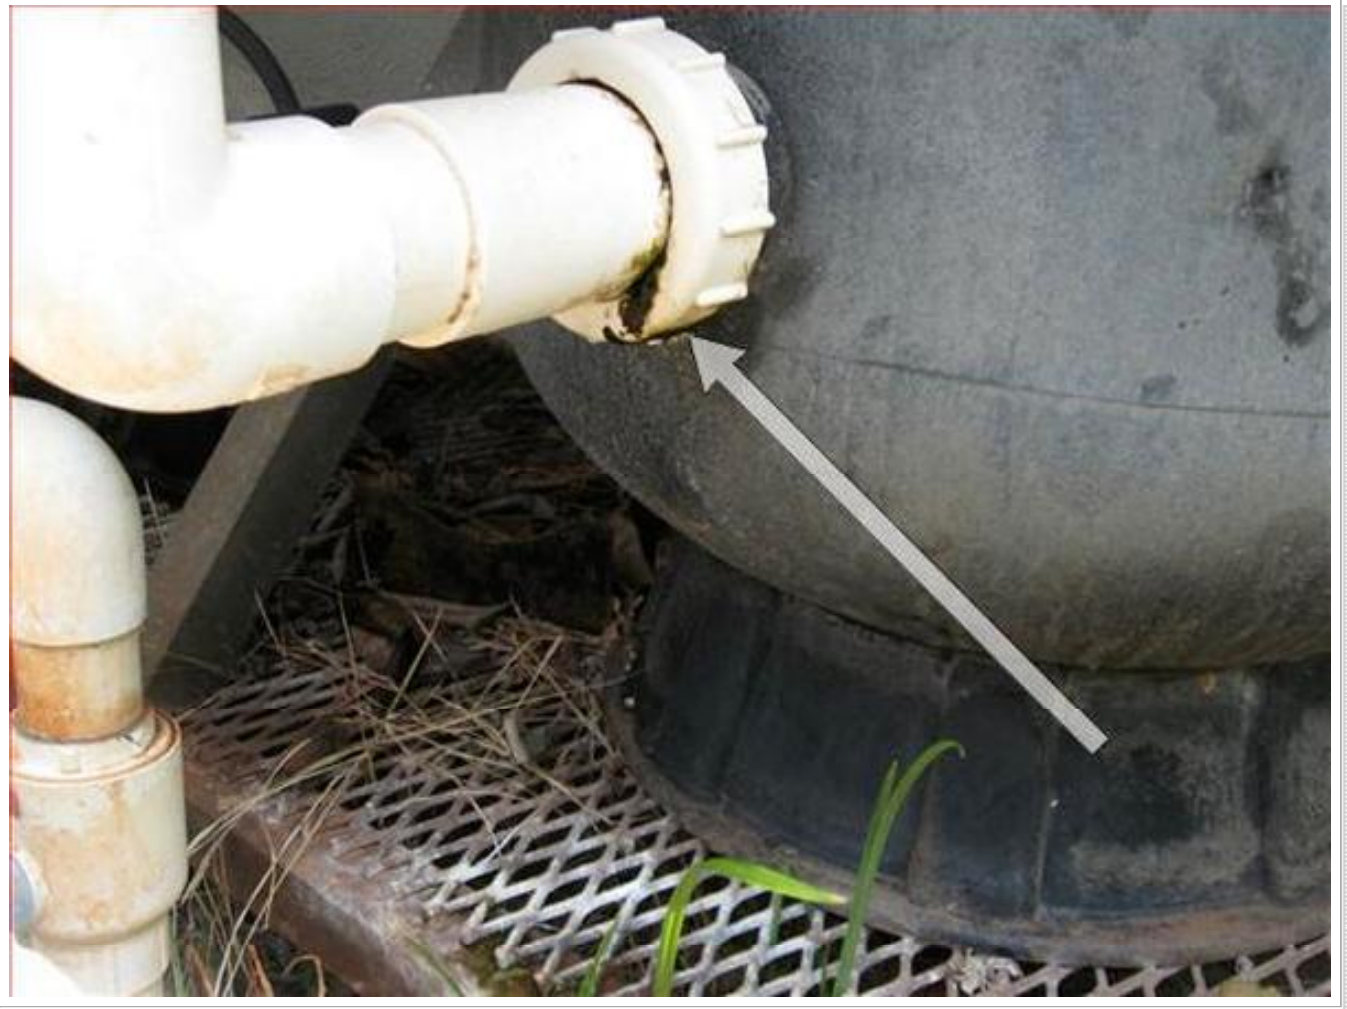
Figure Number 27

Minor water leak/drip noted on connection for pool filter. Repair as needed.

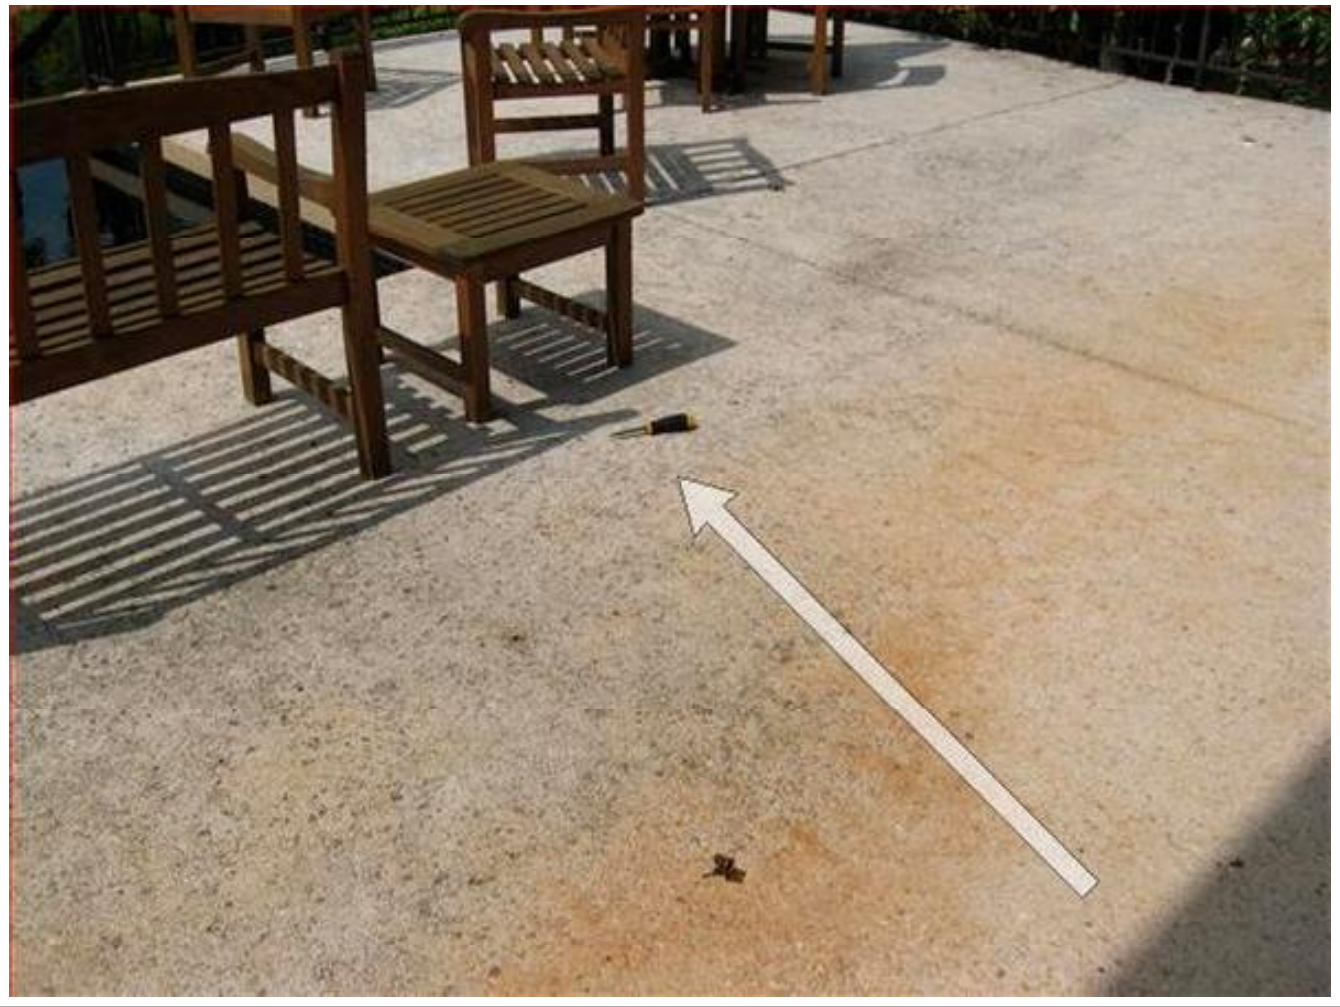
Figure Number 28

Noted hollow sounds at pool deck. Monitor and repair as needed.

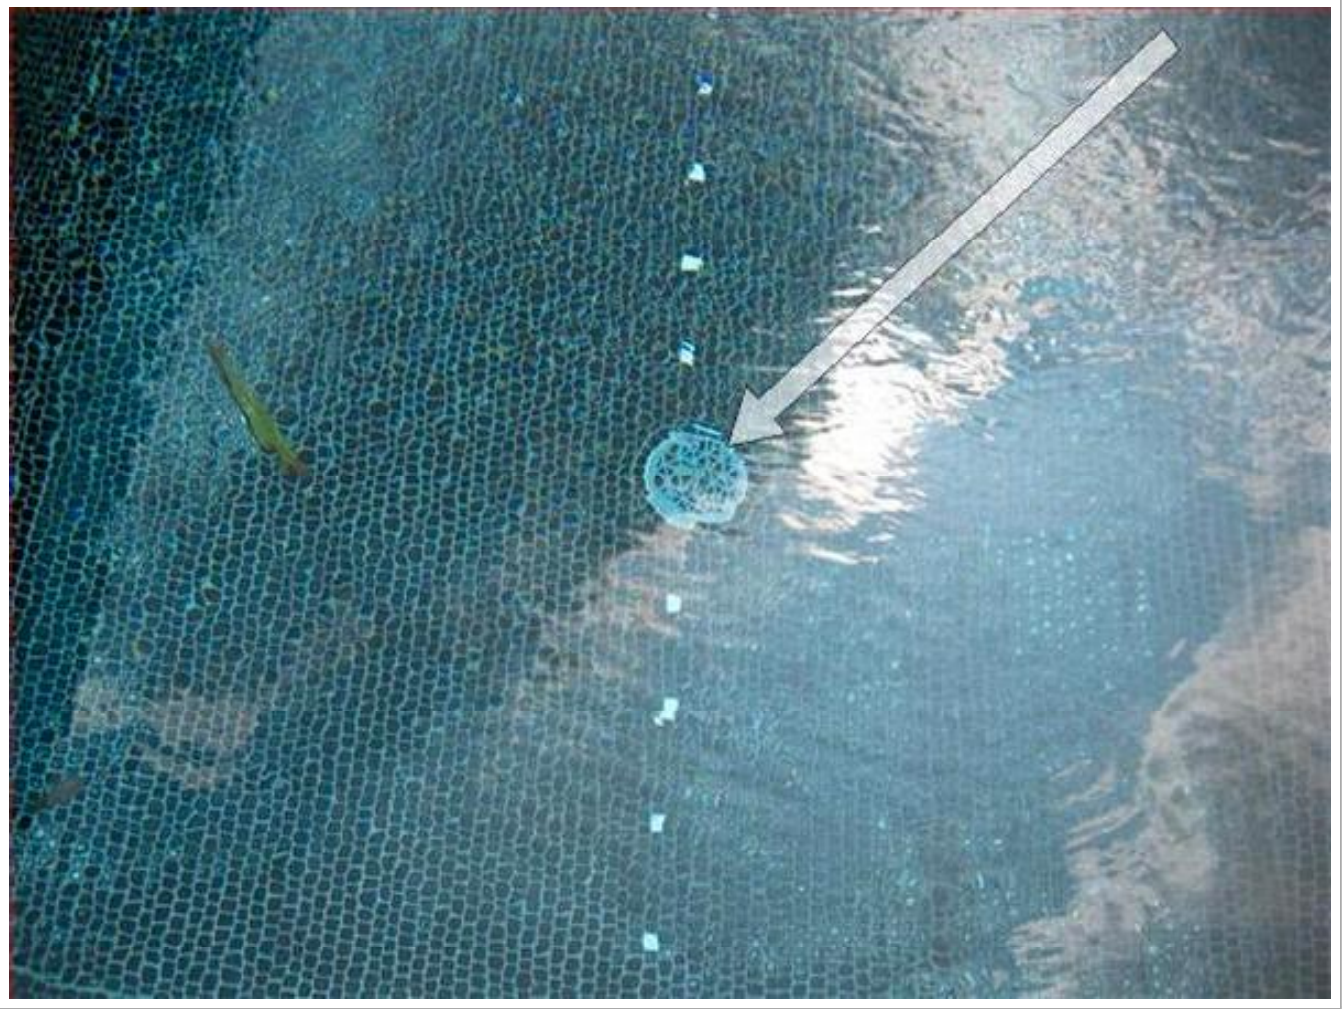
Figure Number 29

Floor return noted at pool. Review possible safety issues regarding this type with pool expert or online.

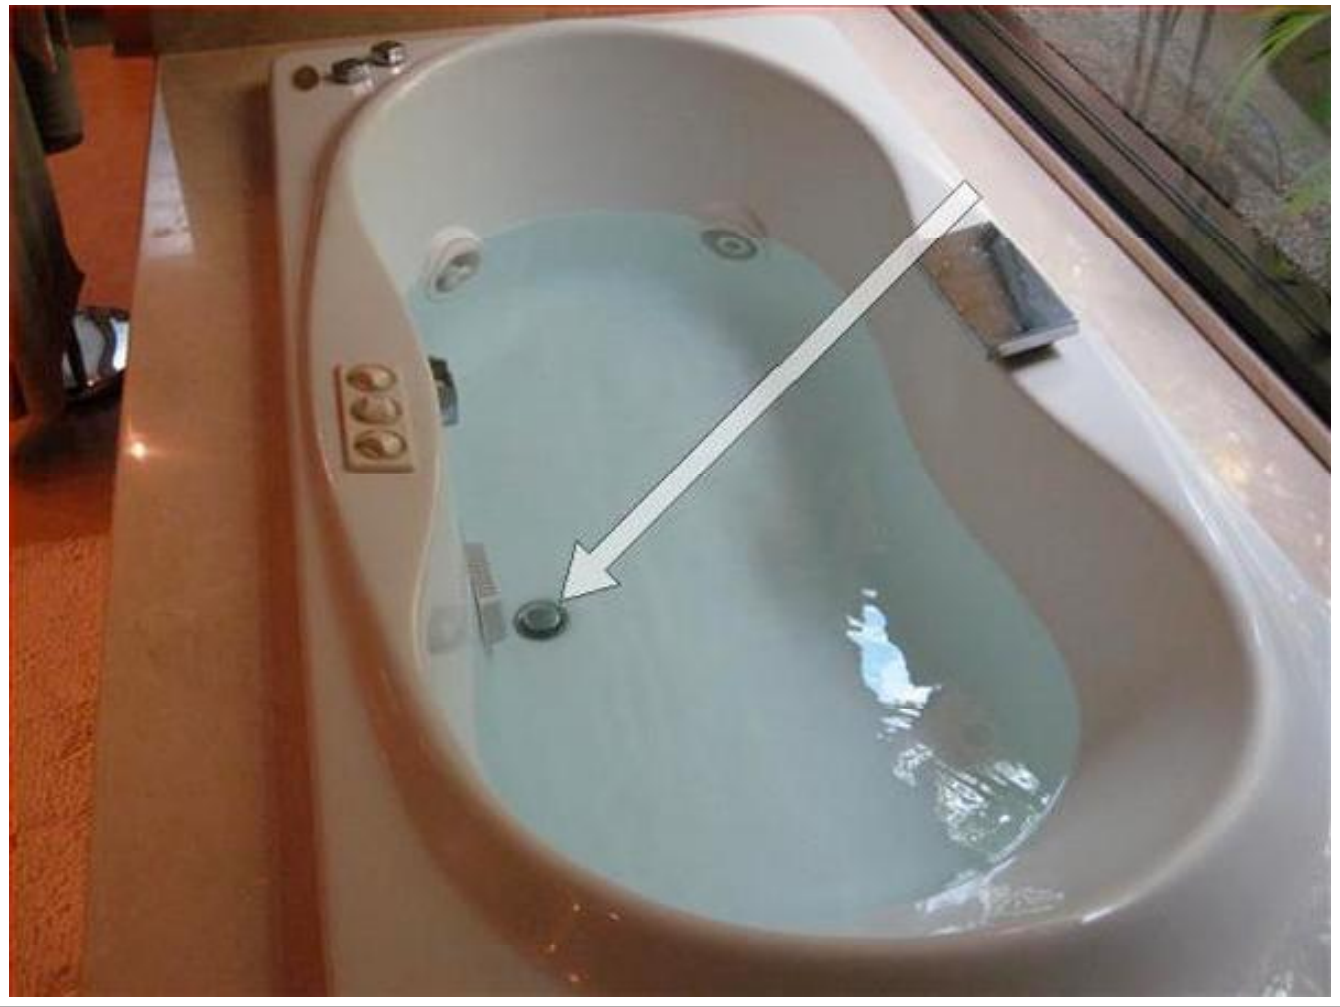
Figure Number 30

Remarks	<ul style="list-style-type: none"> <li>● Tub in master bath was noisy when drained. Repairs recommended as needed. (See Figure #30)</li> <li>● See Summary Remarks</li> </ul>

Tub in master bath was noisy when drained. Repairs recommended as needed.
